SUBMERGED:

**Study of the Destruction
of the Kakhovka Dam and
Its Impacts on Ecosystems,
Agrarians, Other Civilians,
and International Justice**

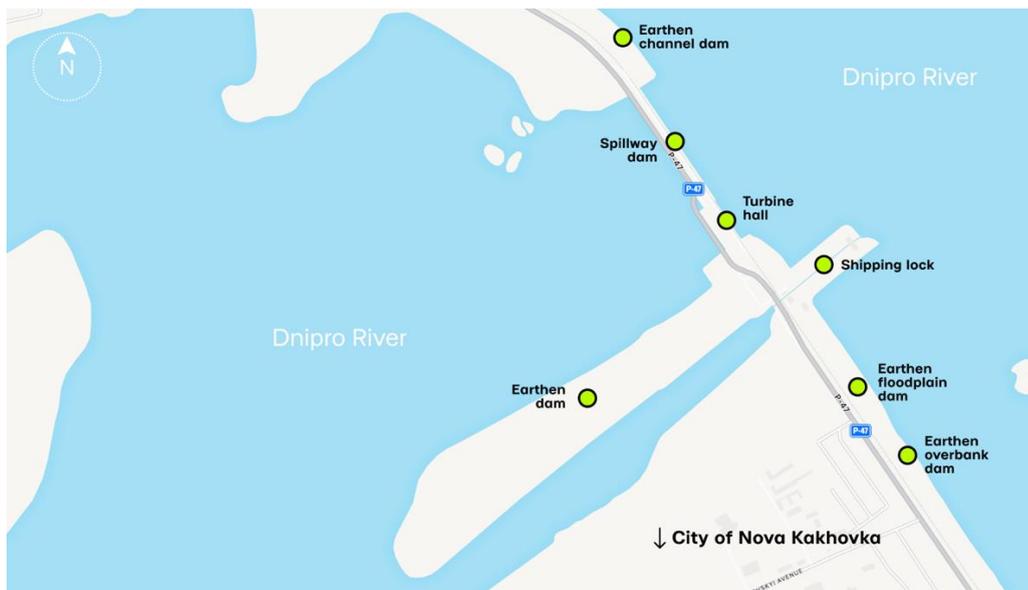
The Kakhovka hydroelectric complex scheme.

The construction of the HPP necessitated the development of an entire complex of facilities surrounding it. The entire Kakhovka hydroelectric complex consists of an earthen channel dam, a spillway dam featuring 28 spillway spans, a hydropower plant building, an earthen Dam between the lock and the hydropower plant, a shipping lock, an earthen floodplain dam, and an earthen overbank dam.

(Subsequently, all these Dams will be collectively denoted as the Kakhovka Dam.)⁹ Additionally, atop the Kakhovka Dam, there is both a railroad and a highway. The architectural ensemble of the Kakhovka hydroelectric complex is distinctive in Ukraine, combining monumental architecture with elements of Soviet modernism.¹⁰

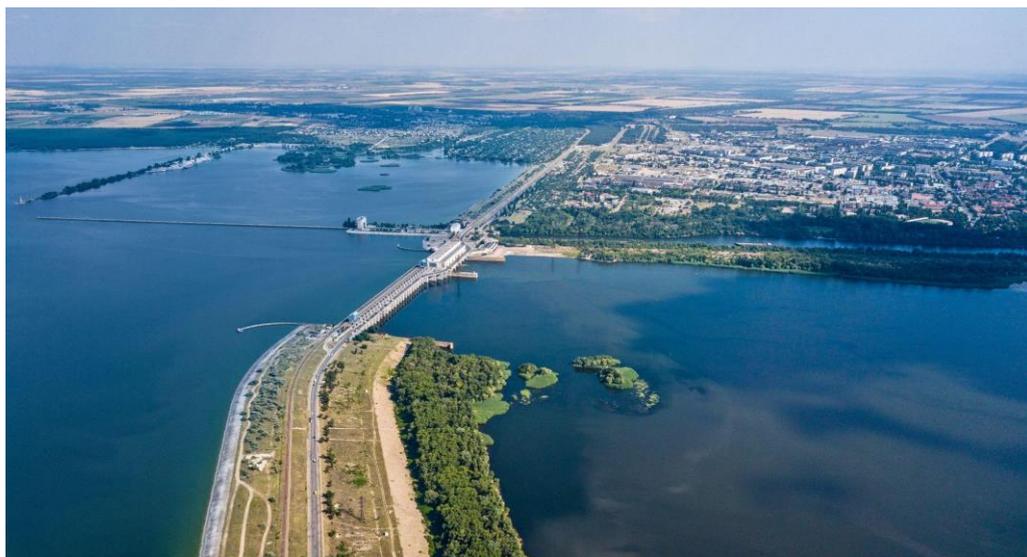
The Kakhovka hydroelectric complex. Aerial view.

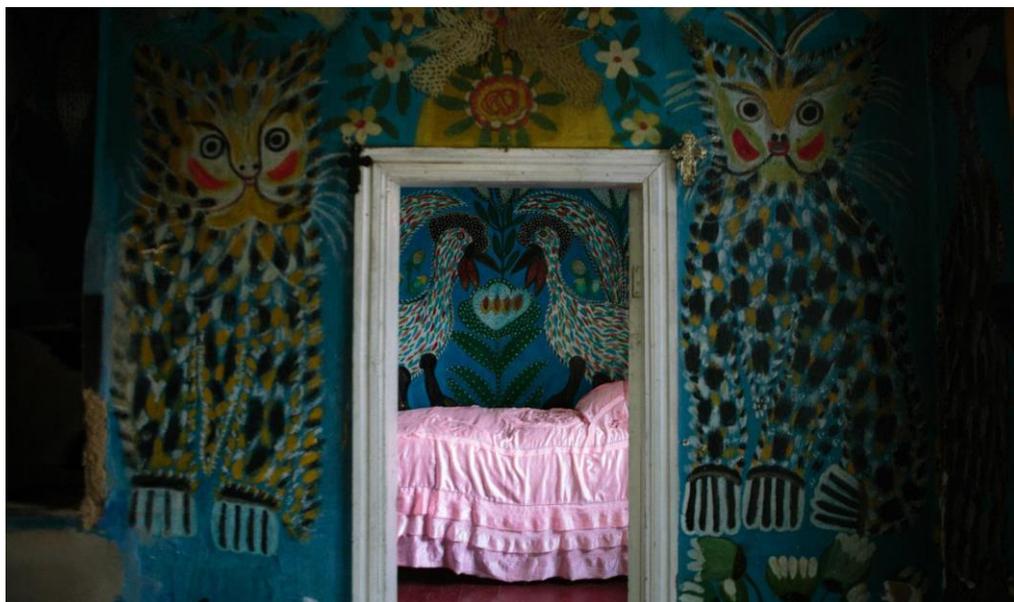
The House-Museum of Polina Raiko in Oleshky, Kherson Oblast – a Ukrainian artist known for her works in the genre of naive art. The site was partially destroyed due to flooding caused by the destruction of the Kakhovka Dam.

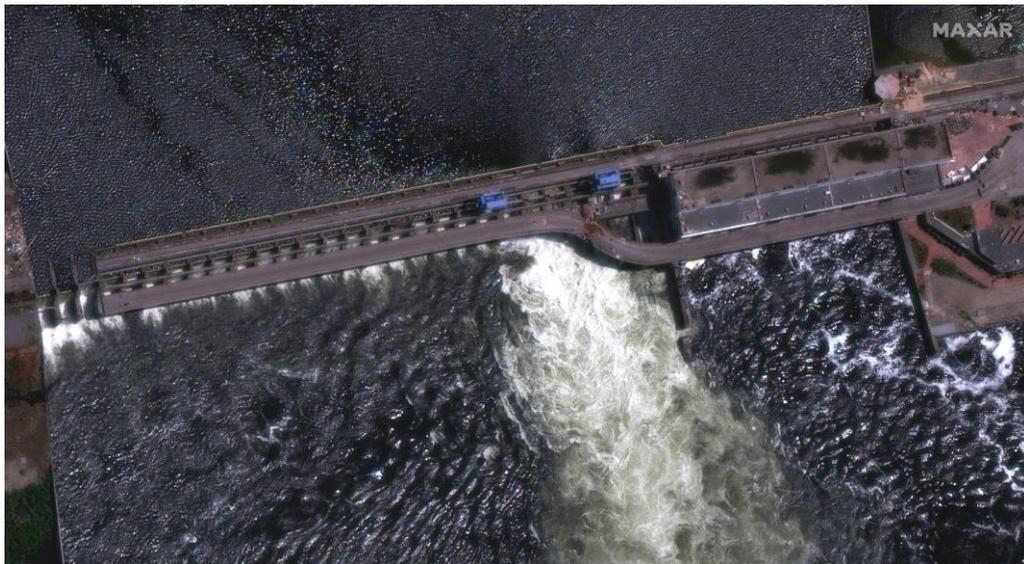
damaged or destroyed. At the time of the disaster, the water level in the Kakhovka Reservoir was at an exceptionally high level – 17.26 meters.⁷⁷ Satellite images show that water from the Reservoir overtops the sluices. These facts were used as evidence that the Dam could have gradually collapsed under the extreme water pressure.⁷⁸

Kakhovka Dam on May 28, 2023. Source: @evanhill via X

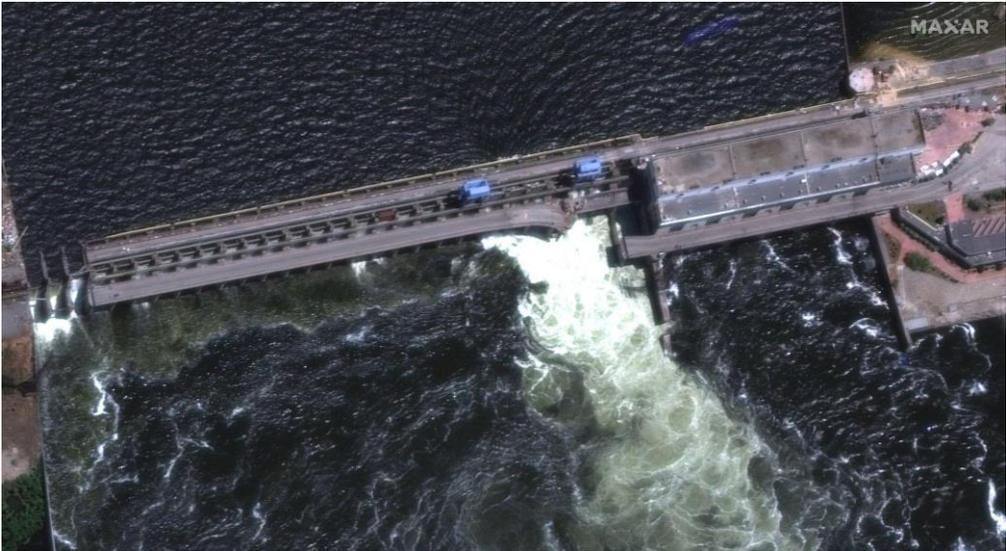
Kakhovka Dam on June 5, 2023. Source: @evanhill via X

The version primarily emerged through the comparison of 2 satellite images of the Kakhovka Dam: one taken on May 28, 2023, and the other on June 5, 2023, the day before the explosion.⁷⁶ The latter image shows that a section of the road and sluice gates (movable gates allowing water to flow) had been recently

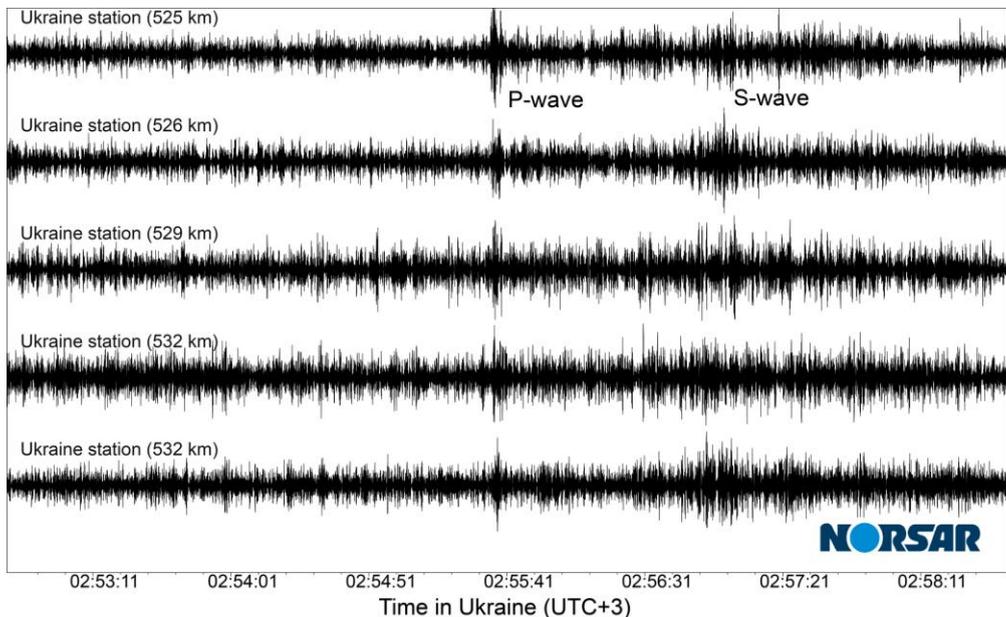
The magnitude estimated between 1 and 2 am on June 6. Source: Norsar

However, this theory overlooks several crucial facts. For instance, the NORSAR seismic stations in Ukraine and Romania recorded focused pulses of energy, which are typical of an explosion. The data reveals clear signals on June 6, 2023, at 2:35 AM and 2:54 AM.⁷⁹ Scientists report that the locations of both explosions were determined to be in the area of the Dam, albeit with an uncertainty of about 20-30 kilometers. This uncertainty arises from factors such as the distance from the Dam to the sensors (approximately 500-600 kilometers), the arrangement of sensors used for the location, measurement uncertainties, and unknowns related to the propagation of seismic waves in the Earth.

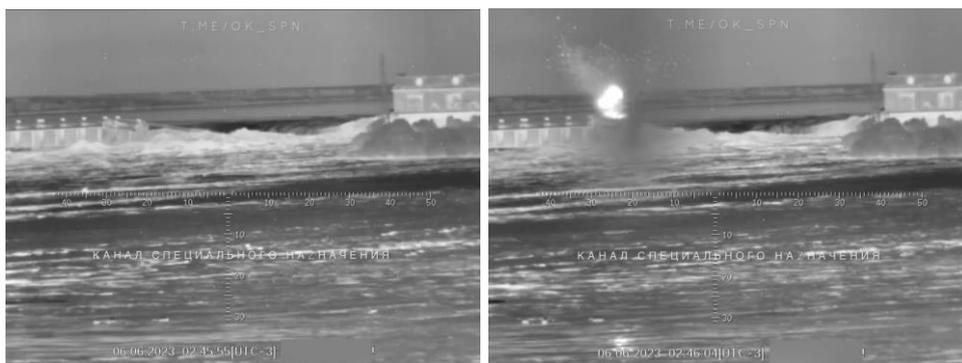
Screenshots from a video recorded by a Russian soldier with a thermal imager. Source: @okspn via Telegram

The video also depicts the detonation of either an explosive device, which we conclude would have been placed by the Russian military on the Dam, or, more likely, a mine that was washed away by a stream of water. Based on the visual characteristics of the explosion, investigators found no reason to believe that it was caused by a shell or a missile impact. Numerous videos from open sources showcase similar explosions, suggesting that the area around the Kakhovka HPP was heavily mined.⁸⁶

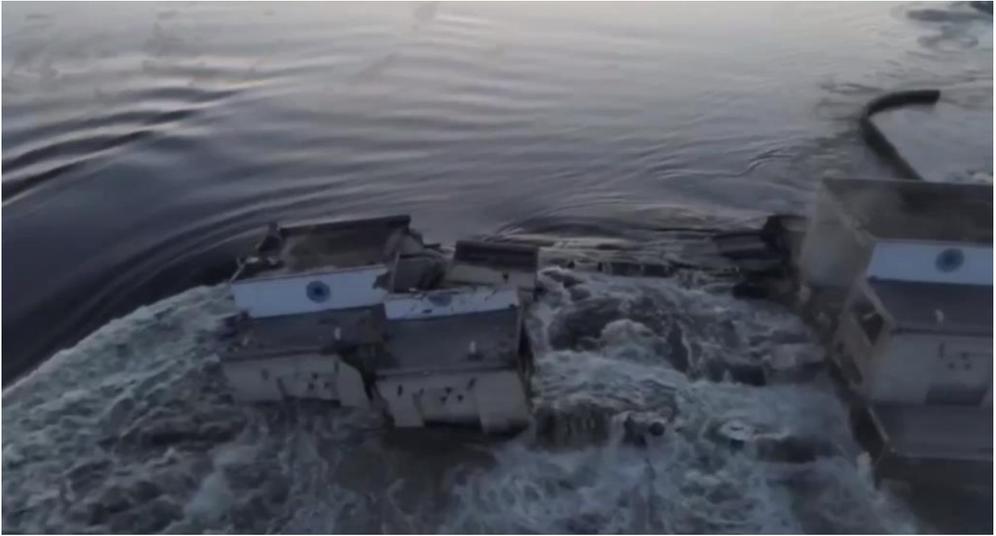
Screenshot from a video of the destruction of the Kakhovka Dam. Source: @voenacher via Telegram

Another video depicting the aftermath of the destruction of the Kakhovka Dam shows the collapse of the hydroelectric power plant building: the central part of the structure is entirely destroyed, and the northern part is severely tilted.⁸⁷ This destruction probably occurred due to damage to the building's foundation caused by the second explosion (2:54 AM).

The exact recording time of this video is unknown but considering that the sun in the video is below the horizon, we can assume that it was recorded at dawn. According to the SunCalc service, the dawn of June 6, 2023, lasted from 4:15 to 4:53 AM.⁸⁸ This implies that this video was recorded 90-128 minutes after the one captured with a thermal imager. This timeframe does not appear sufficient for a water flow to have caused such damage to the power plant building. Moreover, if the building had collapsed due to water pressure, the collapse would have been initiated in the northern part of the building, near the site of the first breach, as that is where the water flow would have exerted the greatest pressure on the structure.

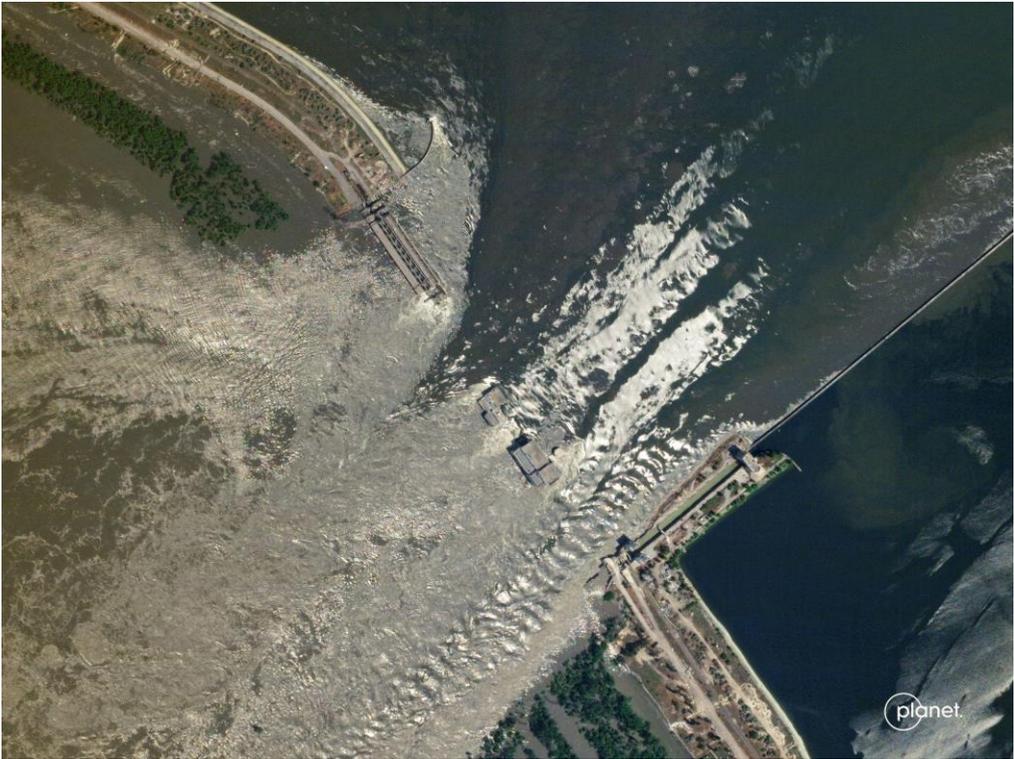
Satellite image of the Kakhovka HPP taken on June 6. Source: @Planet via X

Ukrainian and foreign engineers note that a simple breach of the sluices or even the collapse of a few pillars under water pressure would not result in extensive destruction⁹⁰ and flooding.⁹¹ They are convinced that such destruction most likely was caused by charges set deep in the Dam's structure. The most suitable location for the explosives is a technical passageway running along the concrete base of the Dam. The passageway is accessible only from the engine room, which was under Russian control.⁹²

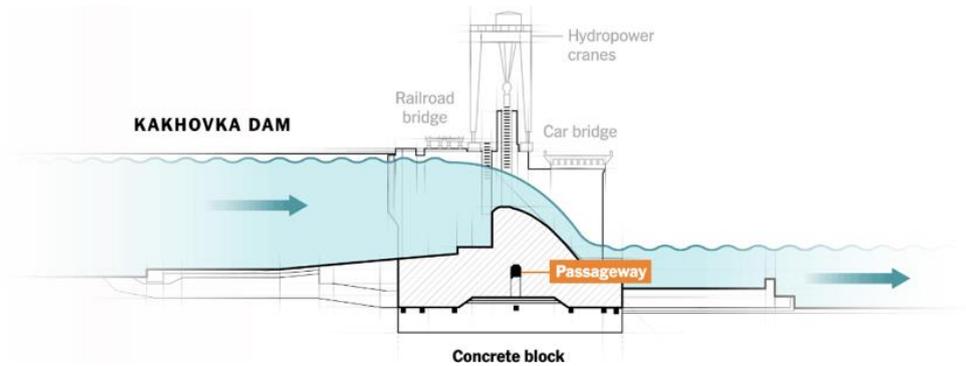
Scheme of the Kakhovka Dam and the location of the passageway. Source: New York Times

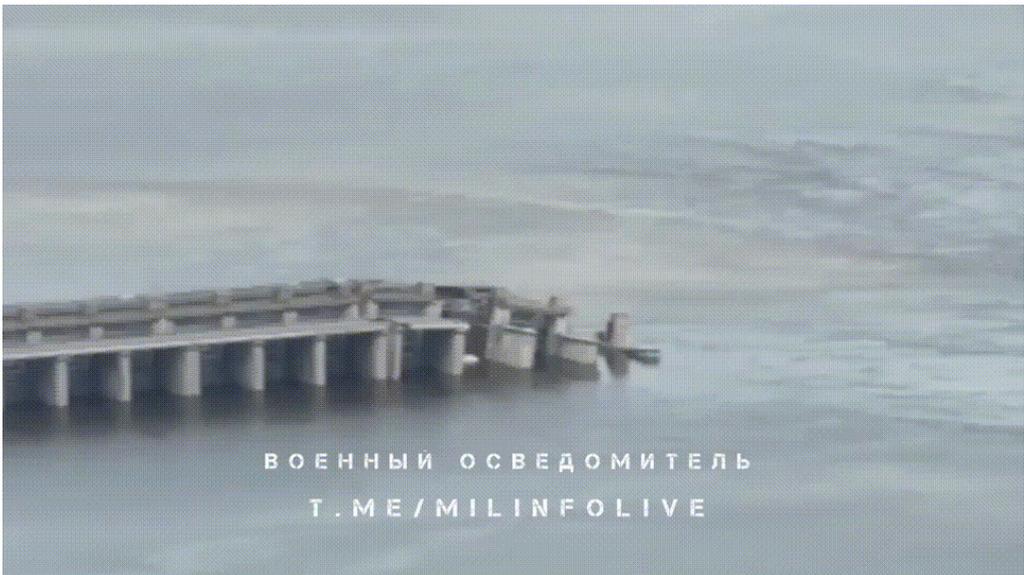
Source: New York Times

This version is further substantiated by the fact that one of the videos depicting the aftermath reveals the absence of the top of the concrete foundation at the location of the initial breach. Such large-scale destruction could likely have been caused only by an explosion deep within the Dam. If the Dam had simply been breached, only the sluices and pillars would have been affected, leaving the top of the concrete foundation intact.

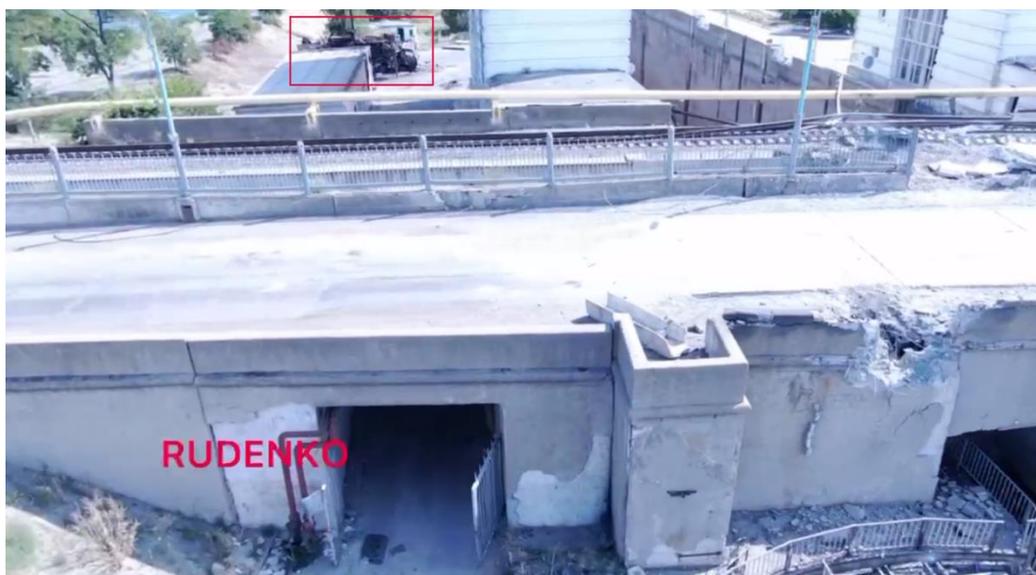
The first confirmed attack on the Dam occurred on July 18, 2022.⁹⁹ On that day, Sergey Kiriyenko, the First Deputy Chief of Staff of the Presidential Administration of Russia, and Volodymyr Saldo, head of the occupation administration of the Kherson Oblast, were visiting the Kakhovka HPP.¹⁰⁰ The shelling damaged several buildings on the territory of the power plant and the roadway next to the lock. There were also reports of the destruction of the Repellent-1 electronic warfare system.¹⁰¹ A video confirming the attack was published in open sources on July 30, 2022.¹⁰² The video also shows damage to the road and railways on the power plant's territory caused by shelling in July. While the main road was not significantly affected, the railway was destroyed. The surface under the tracks collapsed into the lock under the bridge.

Screenshot from the video showing damage to the road and the railway, as well as destroyed Repellent-1. Source: @RtrDonetsk via Telegram

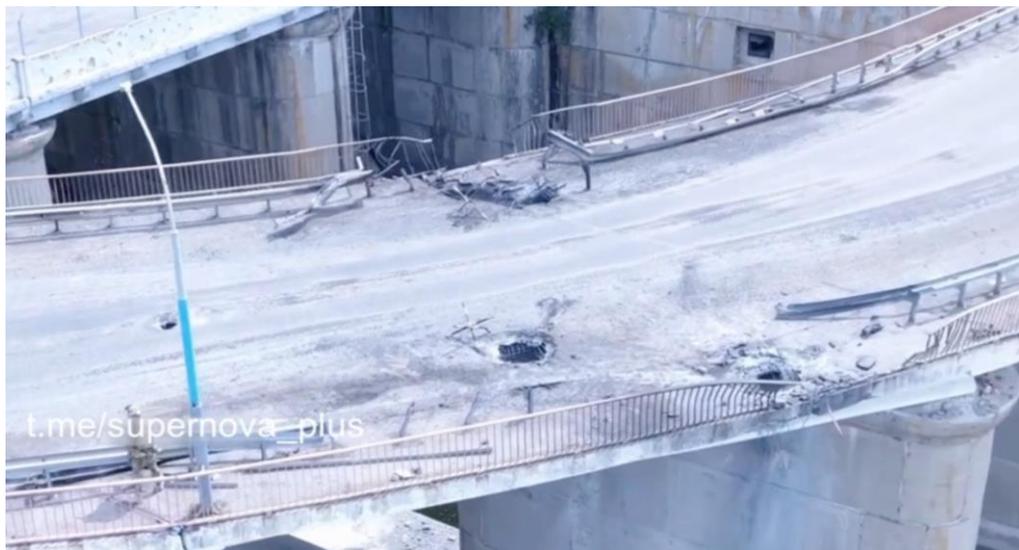
Result of the strikes on August 10, 2022. Source: @supernova_plus via Telegram¹⁰⁵

On August 10, 2022, Ukrainian forces once again targeted the bridges on the Dam,¹⁰³ further complicating their use as logistical arteries.¹⁰⁴ However, the attack did not impact the Dam itself or its functionality.

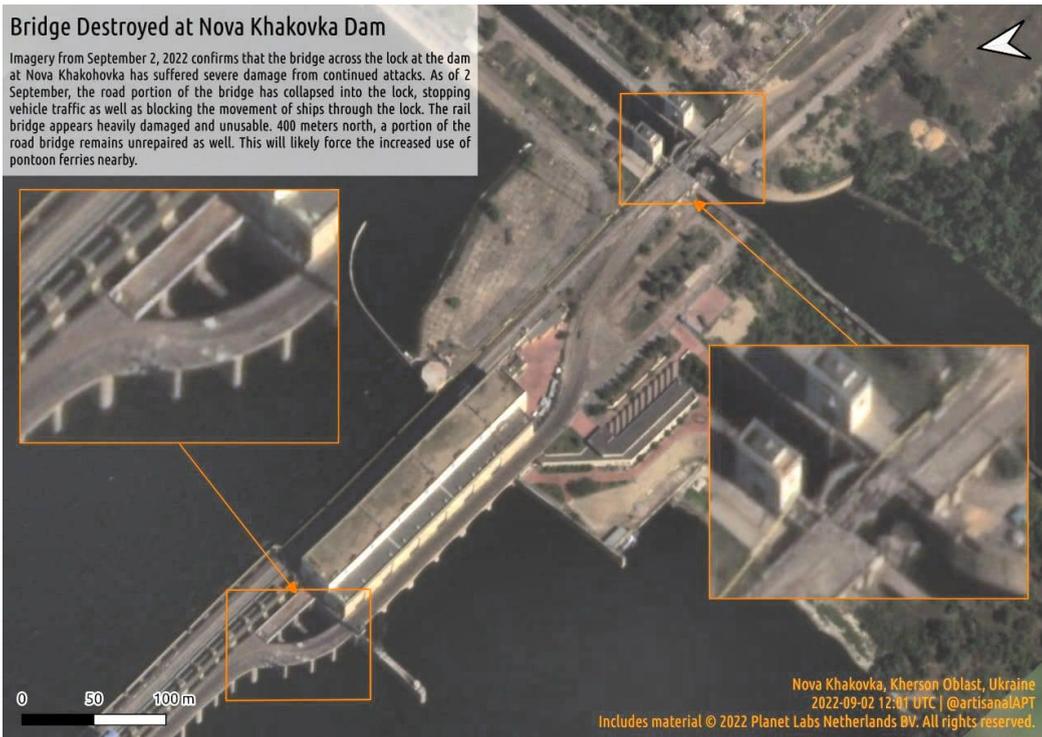
Satellite imagery of the destroyed bridges. Planet imagery from September 2, 2022.
Source: @mil.in.ua

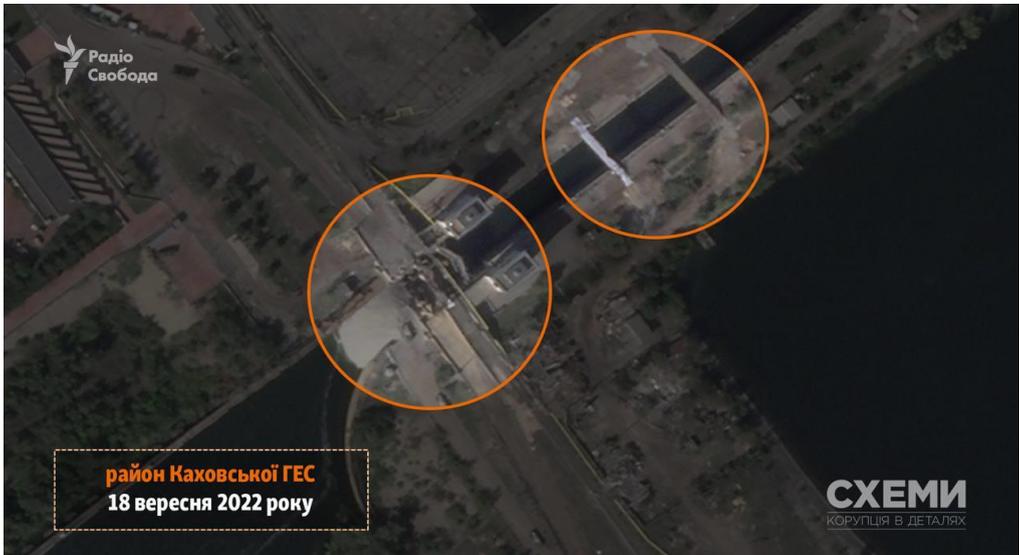
Imagery of the destroyed main bridge and Russian new temporary bridges. Planet imagery from September 18, 2022. Source: @cxemu via Telegram

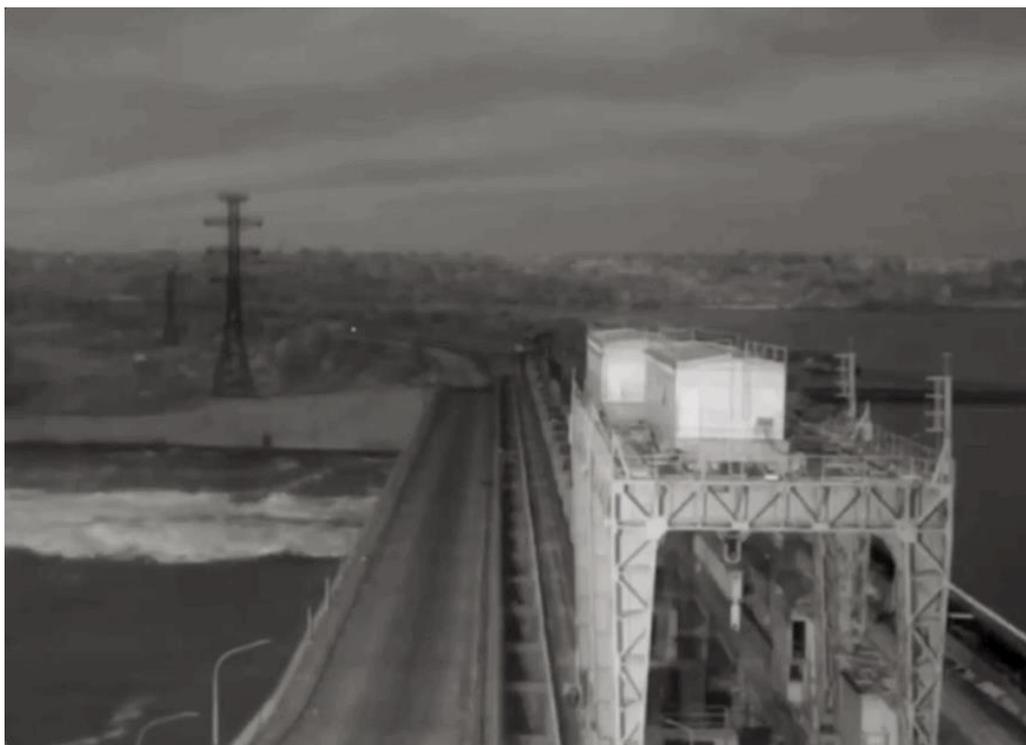
The moment of explosion on November 12. Source: @izvestia via Telegram¹²⁴

Later satellite images show that, despite the powerful explosion, the body of the Dam near the site of the blast remained intact; however, the explosion damaged the sluice gates¹²⁵, which impacted the general functionality and workload of the

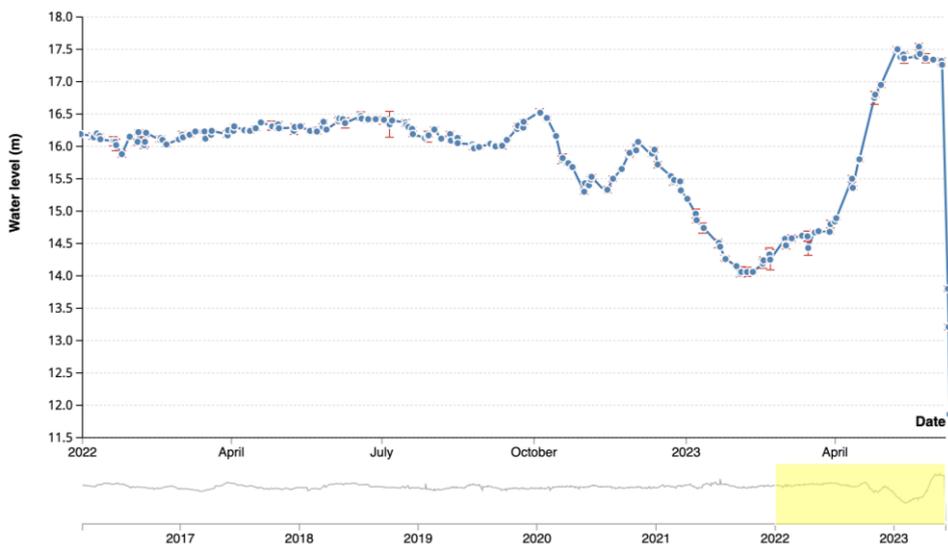
Water level dynamic from December 2022 to July 2023. Source: Hydroweb¹³⁸

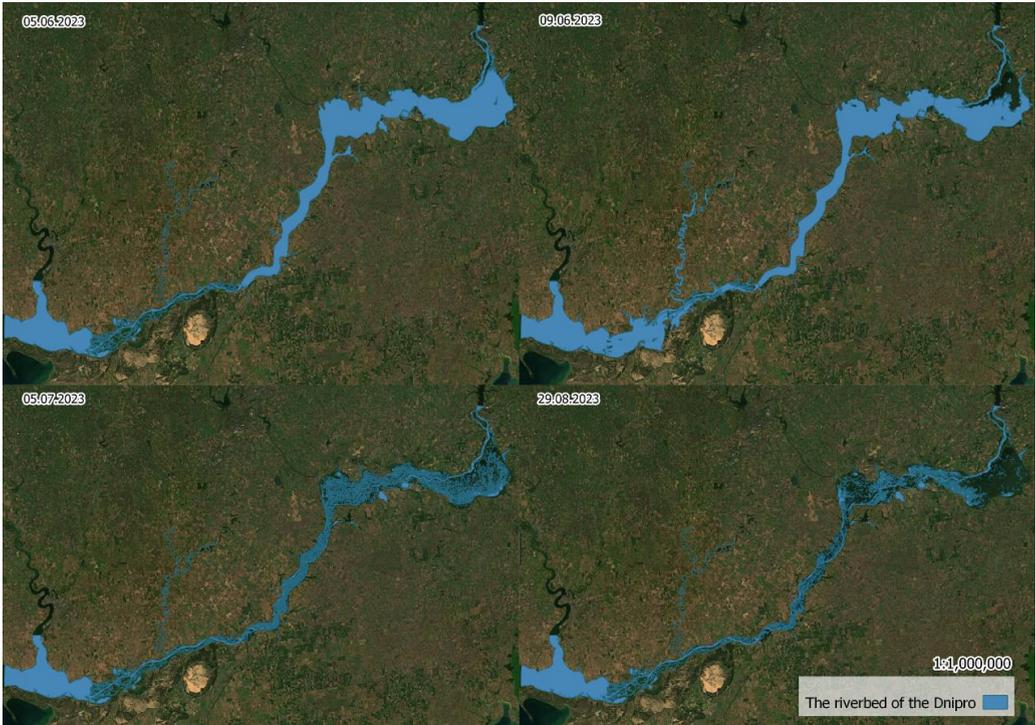
General plan of the entire area of interest with water masks for all available dates, showing water movement for the period from June 5, 2023, to August 29, 2023. The most severe flooding of the area below the Dam is observed in the image from June 9, 2024, then the water gradually recedes. At the same time, a gradual decrease in the water level in the Reservoir is observed.

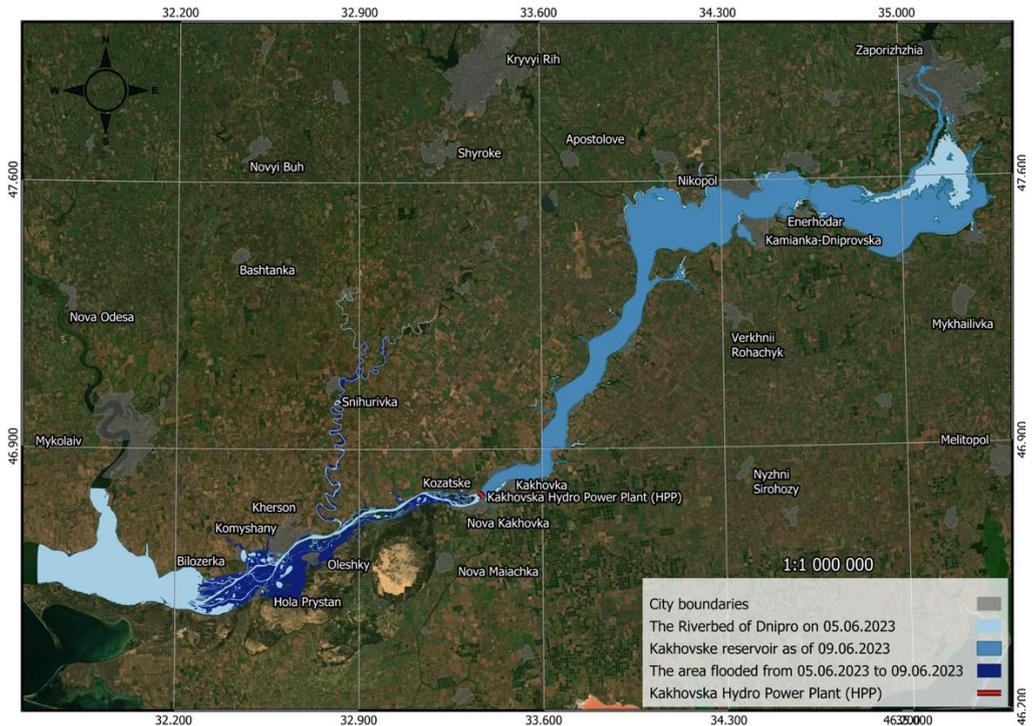
Difference in water mask for the entire territory of interest (geographical scope of water movement analysis) based on the satellite image from June 9, 2023, the third day after the explosion of the Dam

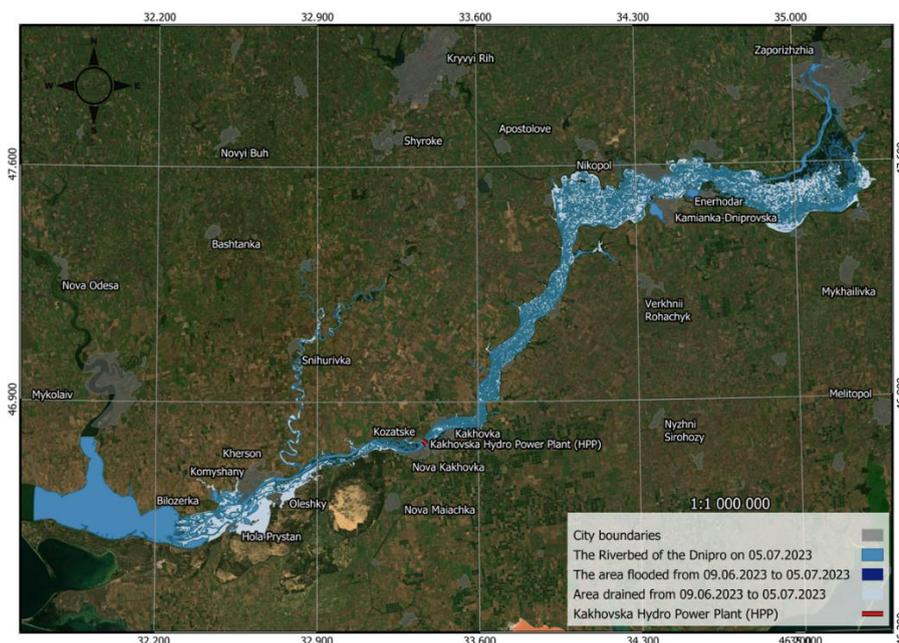
Difference in water mask for the entire territory of interest (geographical scope of water movement analysis) based on the satellite image from July 5, 2023

The flooding caused by the destruction of the Dam gradually dissipated over the course of June and the following months. The difference in water mask for the entire territory of interest based on satellite image from July 5, 2023, demonstrates a substantial drop in water level in the downstream zone from the destroyed Kakhovka Dam, nearly returning to pre-disaster levels. The mapping also shows a considerable decrease in water levels in the upper stream zone, leading to the draining of the Kakhovka Reservoir and Dnipro Riverbed above the Kakhovka Dam.

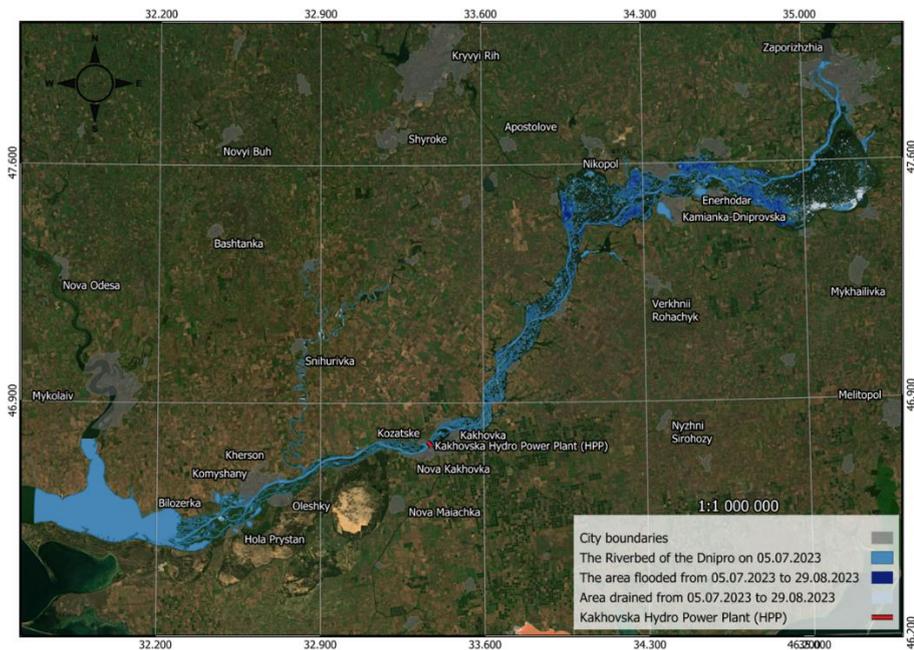
Difference in water mask for the entire territory of interest (geographical scope of water movement analysis) based on the image from August 29, 2023

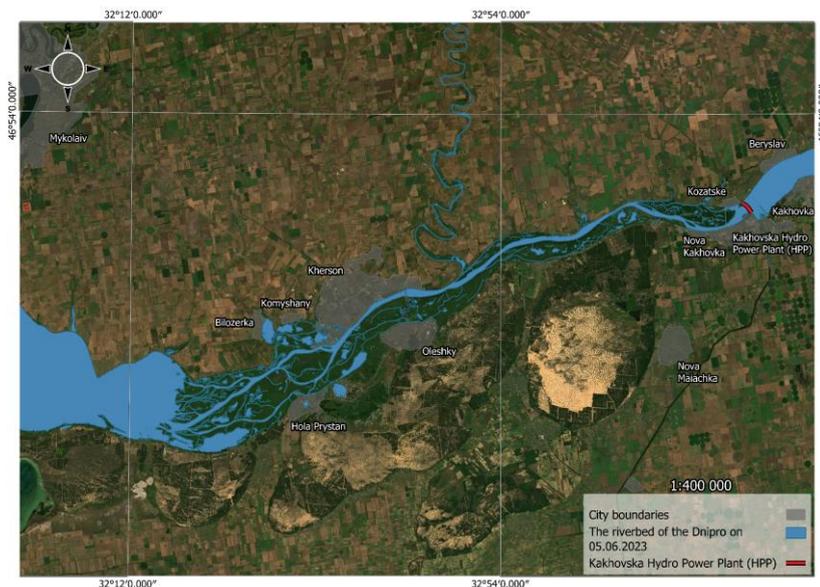
Water mask for the downstream zone (geographical scope of water movement analysis) based on the satellite image from June 5, 2023

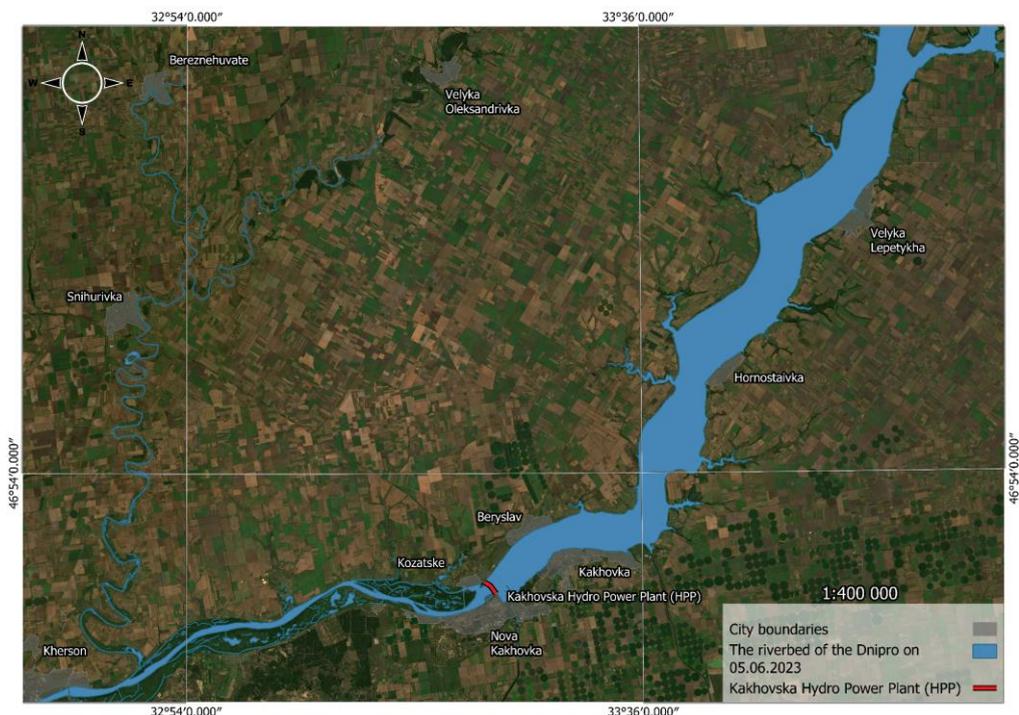
Water mask for the upstream zone (geographical scope of water movement analysis) based on the satellite image from June 5, 2023

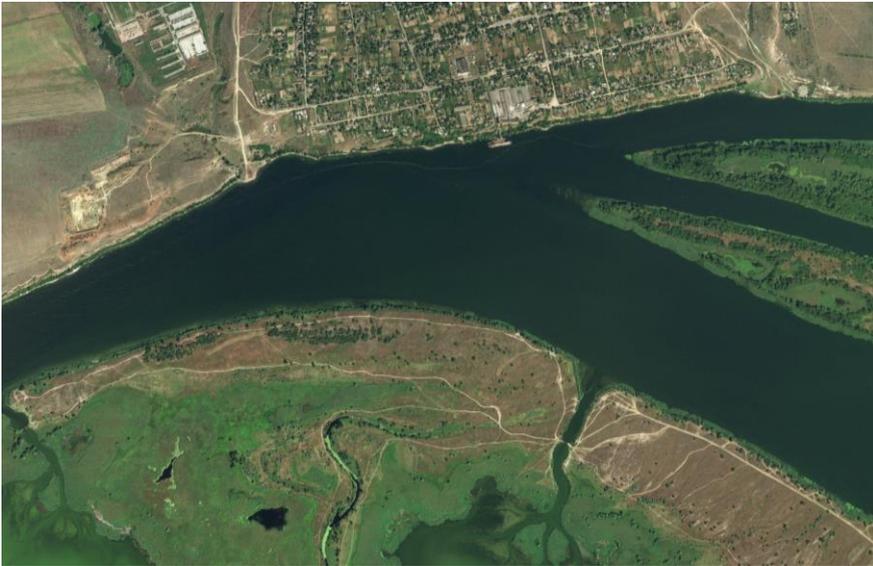
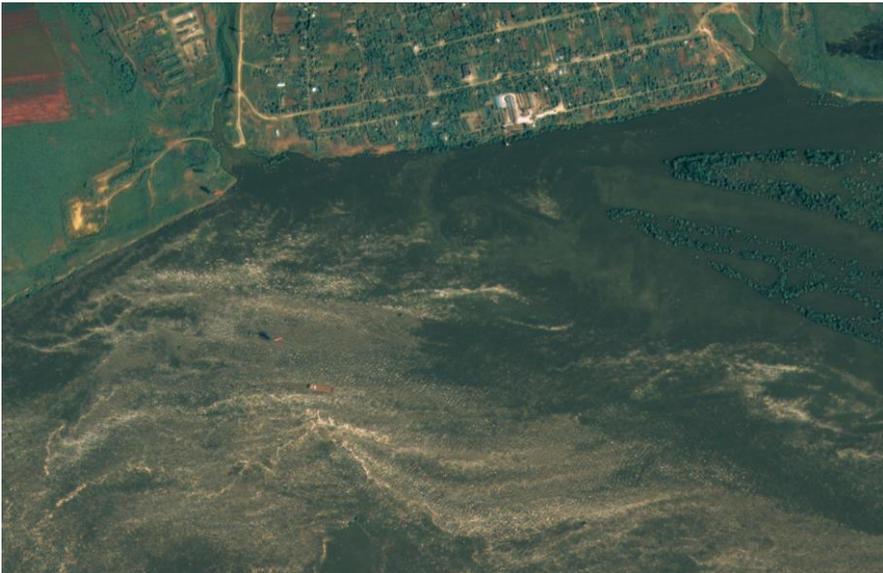
Pre-flooding Geosat image of both banks near L'vove (location 10), resolution 0.75 m

Flooding in both banks near L'vove (location 10), Geosat image from June 6, 2023, resolution 0.75 m

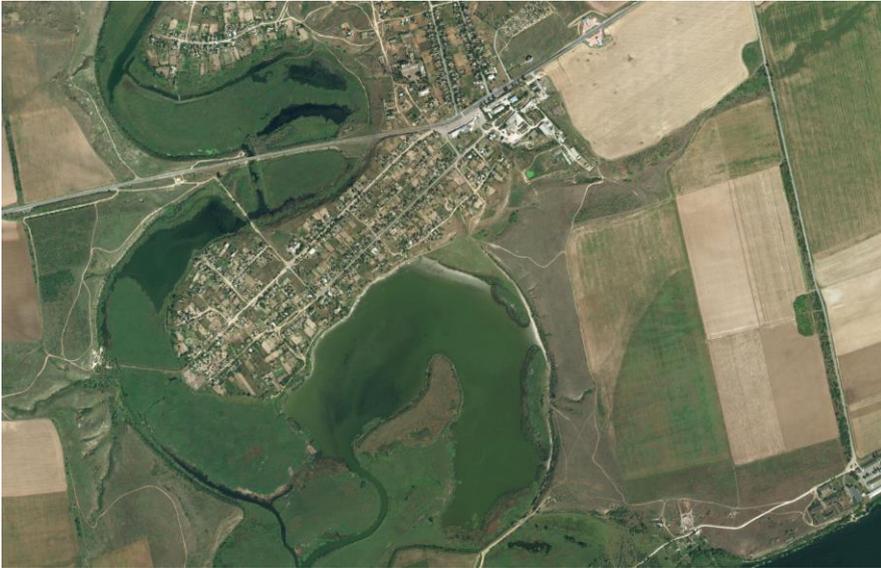
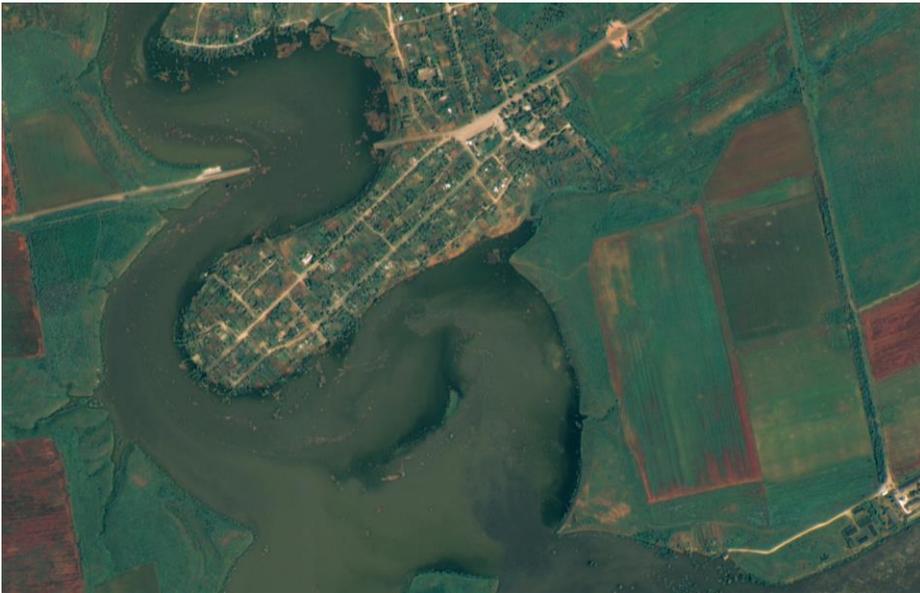
Pre-flooding Geosat image of Tianhynka on right bank of Kherson Oblast (location 7), resolution 0.75 m

Flooding in Tianhynka on the right bank of Kherson Oblast (location 7), Geosat image from June 6, 2023, resolution 0.75 m

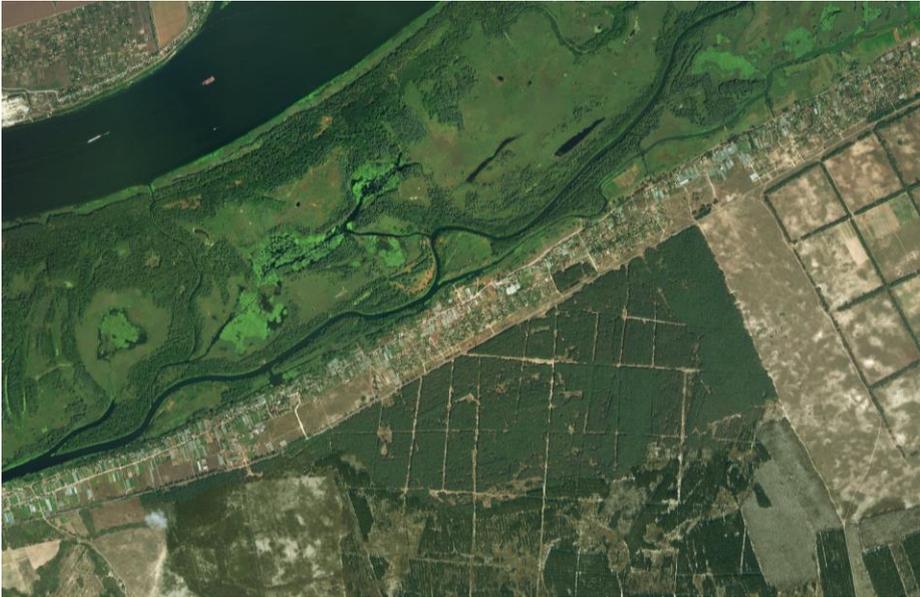
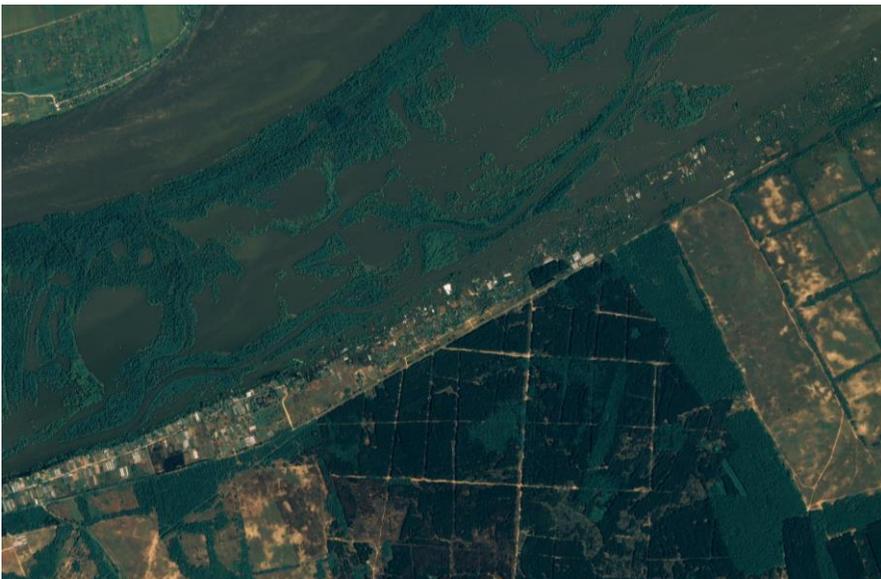
Pre-flooding Geosat image of Krynky on the left bank of Kherson Oblast (location 6), resolution 0.75 m

Flooding in Krynky on the left bank of Kherson Oblast (location 6), Geosat image from June 6, 2023, resolution 0.75 m

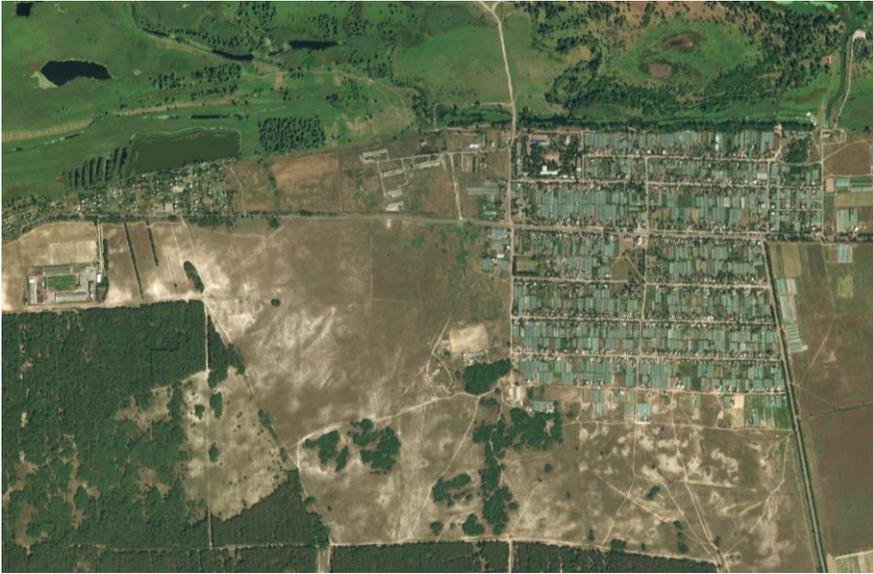
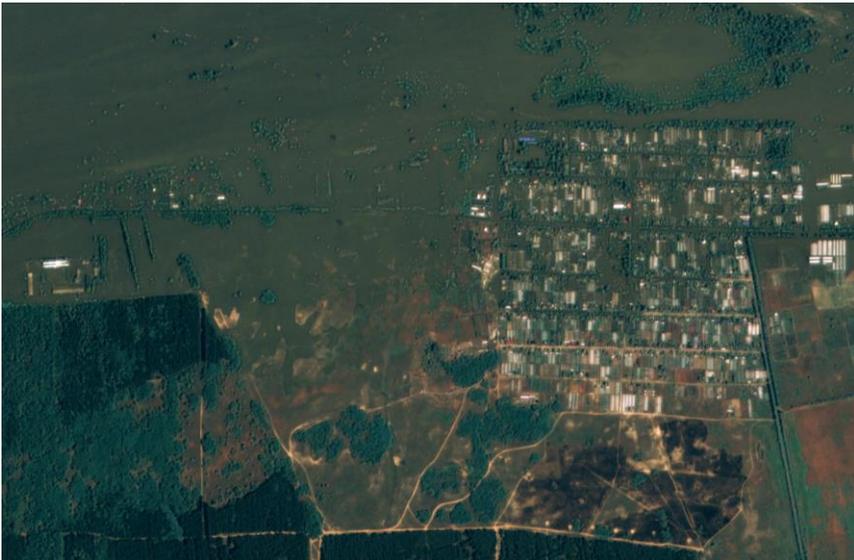
Pre-flooding Geosat image of Korsunska on the left bank of Kherson Oblast (location 9), resolution 0.75 m

Flooding in Korsunka on the left bank of Kherson Oblast (location 9), Geosat image from June 6, 2023, resolution 0.75 m

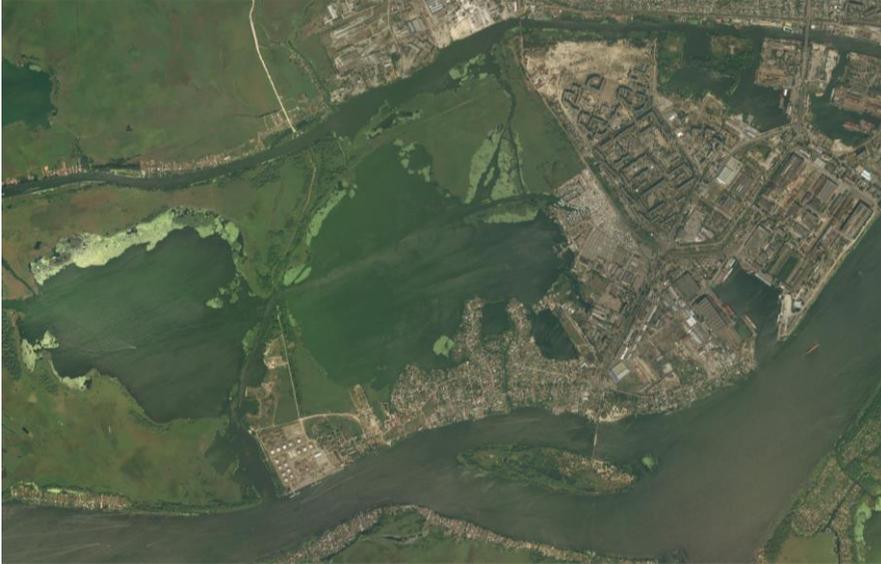
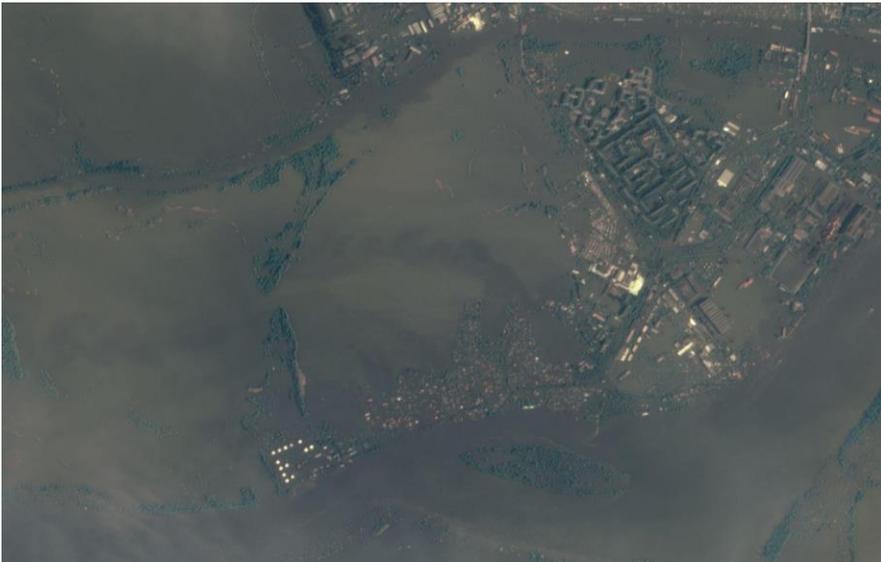
Pre-flooding Geosat image of Kherson Port area (location 2), resolution 0.75 m

Flooding in Kherson Port area (location 2), Geosat image from June 7, 2023, resolution 0.75 m

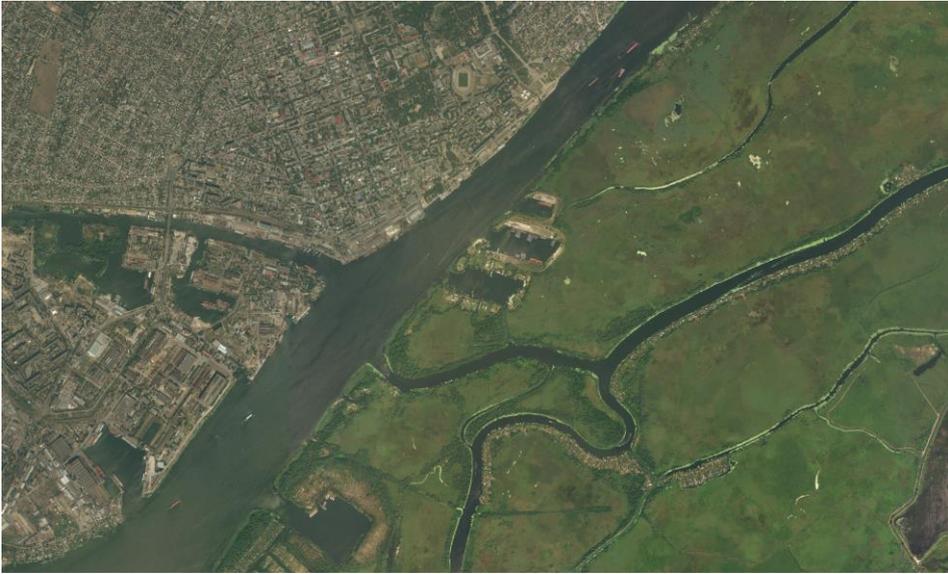
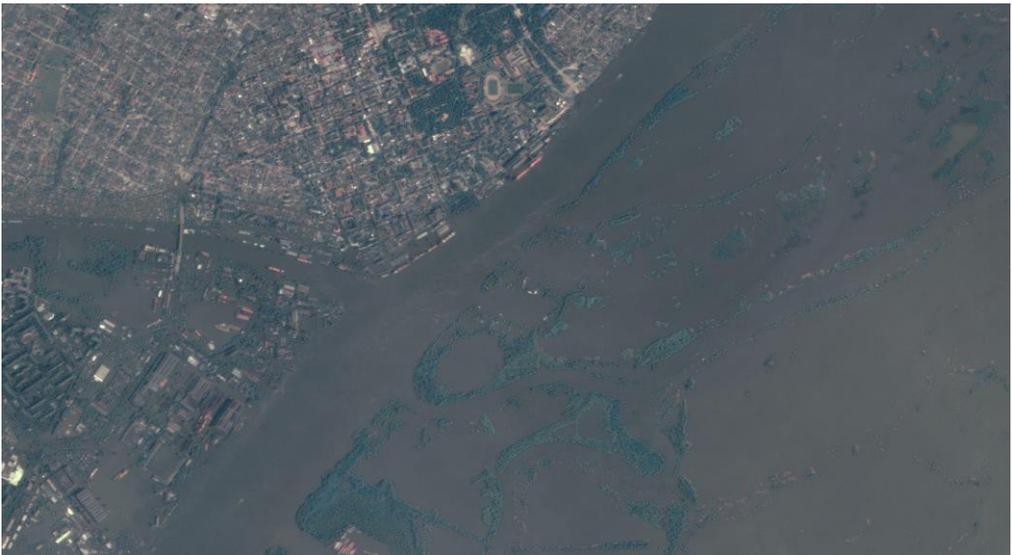
Pre-flooding Geosat image of Kherson Port area (location 3), resolution 0.75 m

Flooding in Kherson Port area (location 3), Geosat image from June 7, 2023, resolution 0.75 m
