SUBMERGED:

**Study of the Destruction
of the Kakhovka Dam and
Its Impacts on Ecosystems,
Agrarians, Other Civilians,
and International Justice**

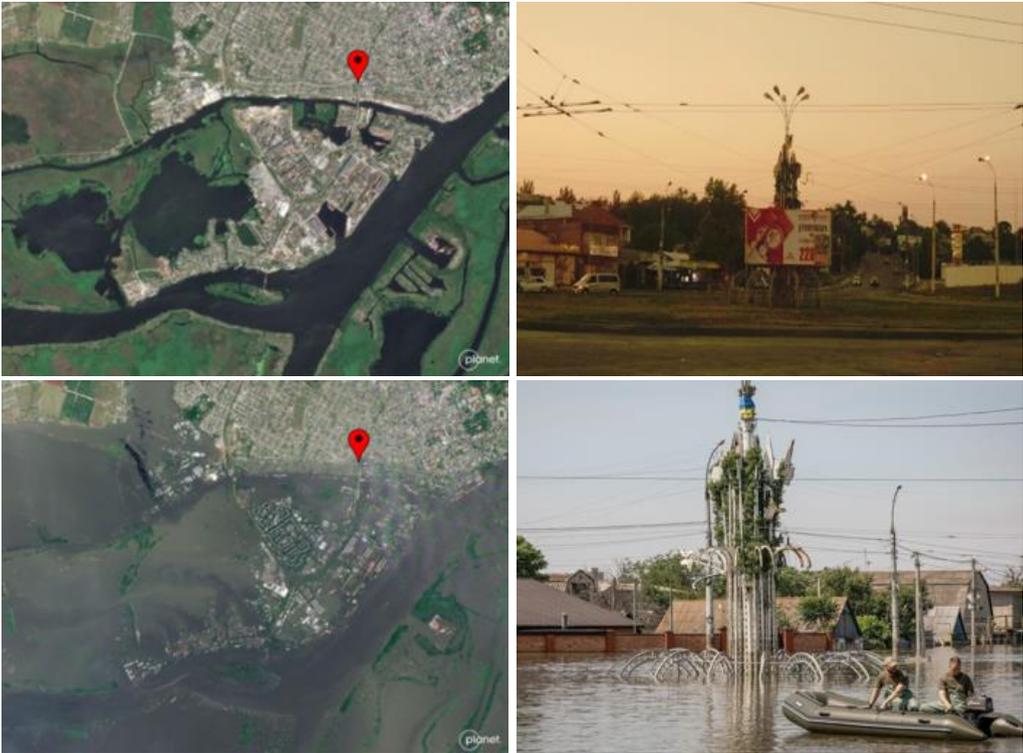
The satellite imagery of the Kherson Korabelna Square on May 15, 2023, and on June 7, 2023 (left). Photo of Kherson Korabelna Square before and after flooding on June 7, 2023 (right). Source: Planet Labs and REUTERS/Alina Smutko¹⁸⁰

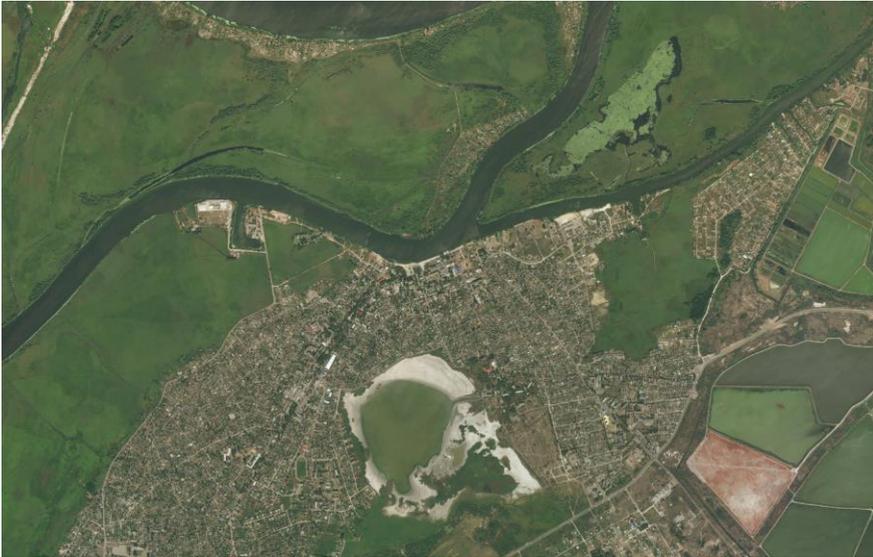
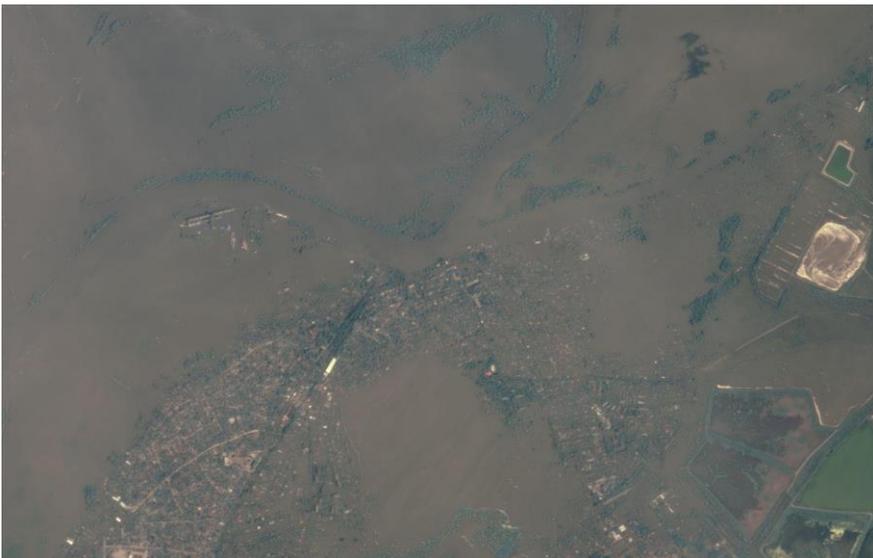
Pre-flooding Geosat image of Hola Prystan on the left bank of Kherson Oblast (location 1), resolution 0.75 m

Flooding in Hola Prystan on the left bank of Kherson Oblast (location 1), Geosat image from June 7, 2023, resolution 0.75 m

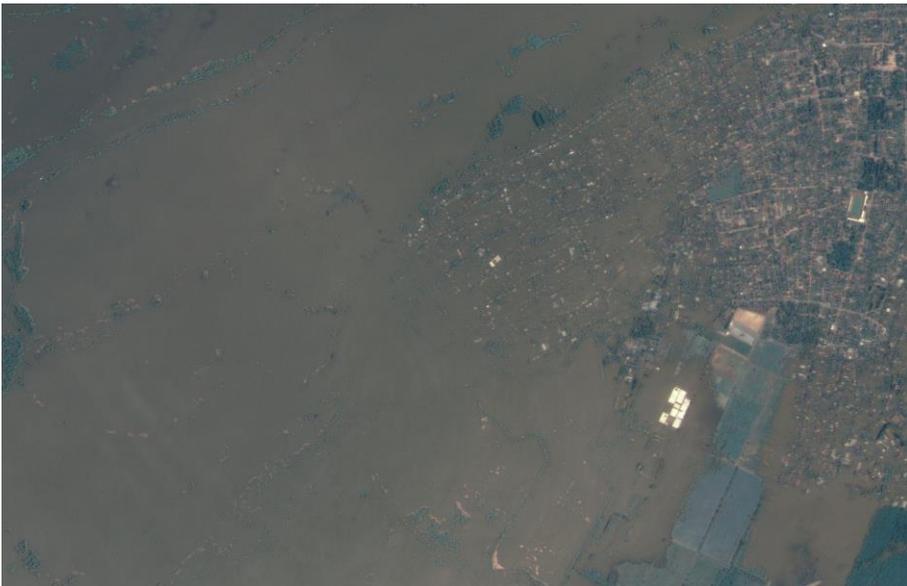
Flooding of Oleshky (location 5), Geosat image from June 7, 2023, resolution 0.75 m

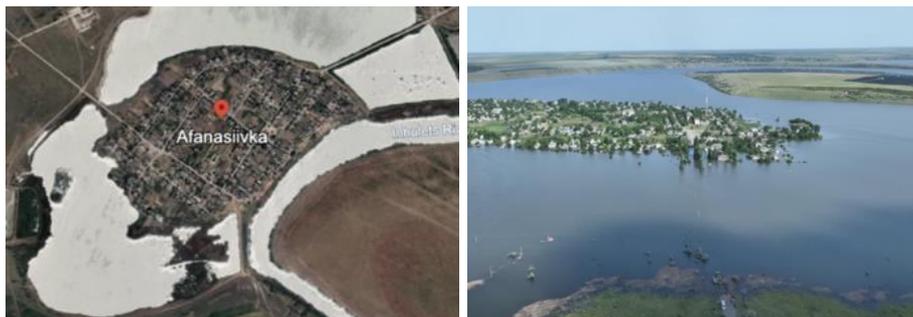
Afanasiivka from a satellite view before June 6, 2023. Source: Google Earth.¹⁹⁰ Drone footage of Afanasiivka after the Kakhovka Dam breach. Source: Suspilne, June 10, 2023¹⁹¹

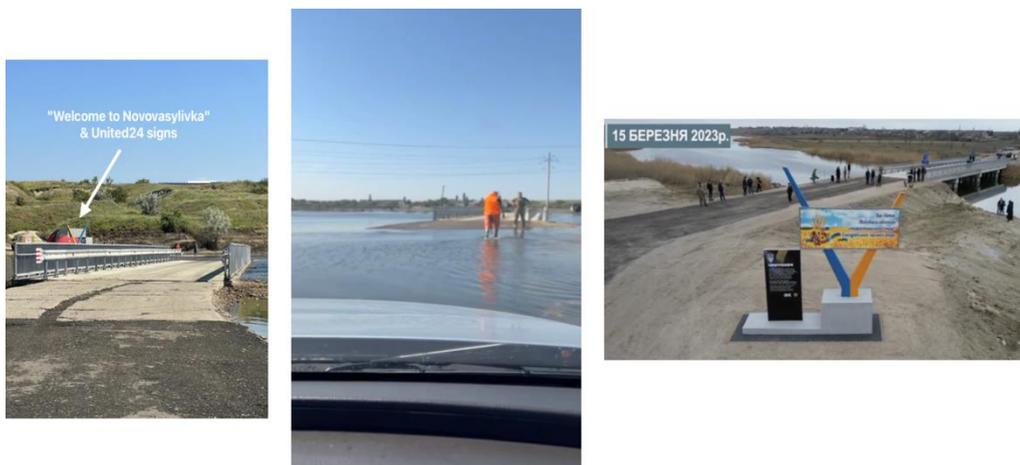
The Novovasylivksyi Bridge after the rebuilding. Source: Ivan Kukhta, March 15, 2023.¹⁹³ The Novovasylivksyi Bridge when the water had already started receding. Source: Ivan Kukhta, June 17, 2023¹⁹⁴

One of the many other bridges that went underwater in Snihurivska Hromada was the newly built Novovasylivksyi Bridge in Novovasylivka village, as mentioned above. In November 2022, when the Russian Armed Forces withdrew from the territory of the local community, they damaged the bridge. Less than 4 months later, the bridge had been rebuilt thanks to the effort of the locals and the United24 Platform.¹⁹²

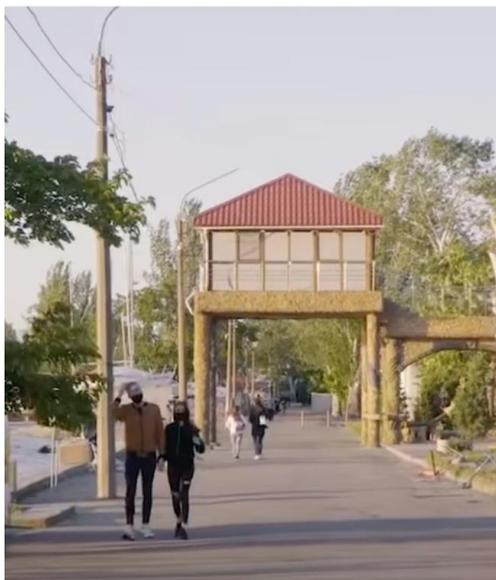
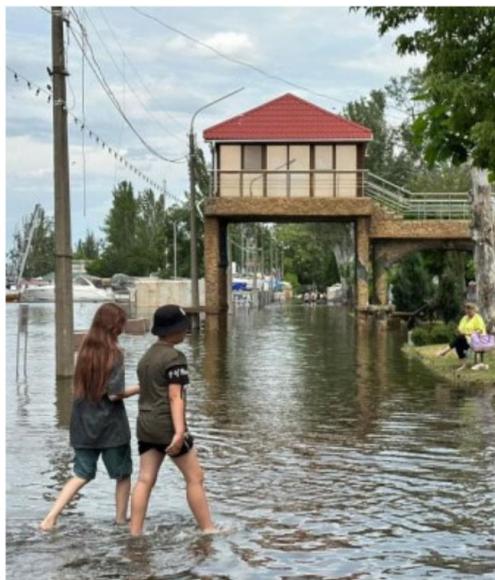
Mykolaiv Yacht Club area in 2021 and on June 8, 2023²⁰⁰

An employee from the Office of the State Agency for Land Reclamation and Fisheries in Mykolaiv Oblast mentioned an even higher water level rise: *"In the center of the city of Mykolaiv near the river, the water rose by about 1.5 meters. It could be observed in many places in the city districts. For example, Namyv District, Nyzhnya Naberezhna, Yacht Club District."*¹⁹⁹

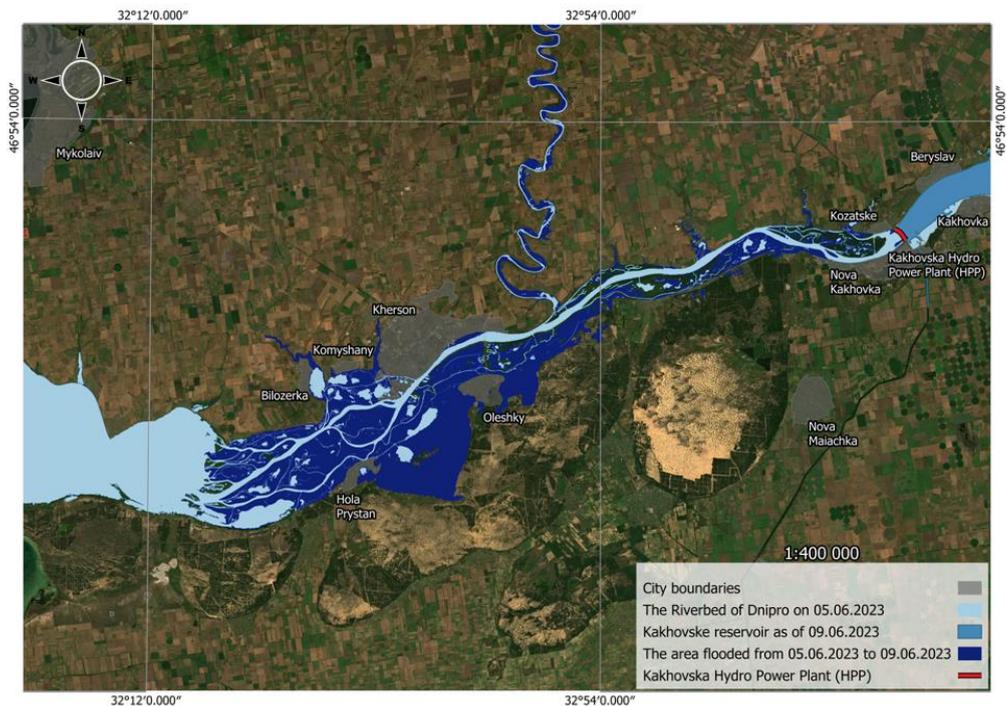
Difference in water mask for the downstream zone (geographical scope of water movement analysis) based on the satellite image from June 9, 2023

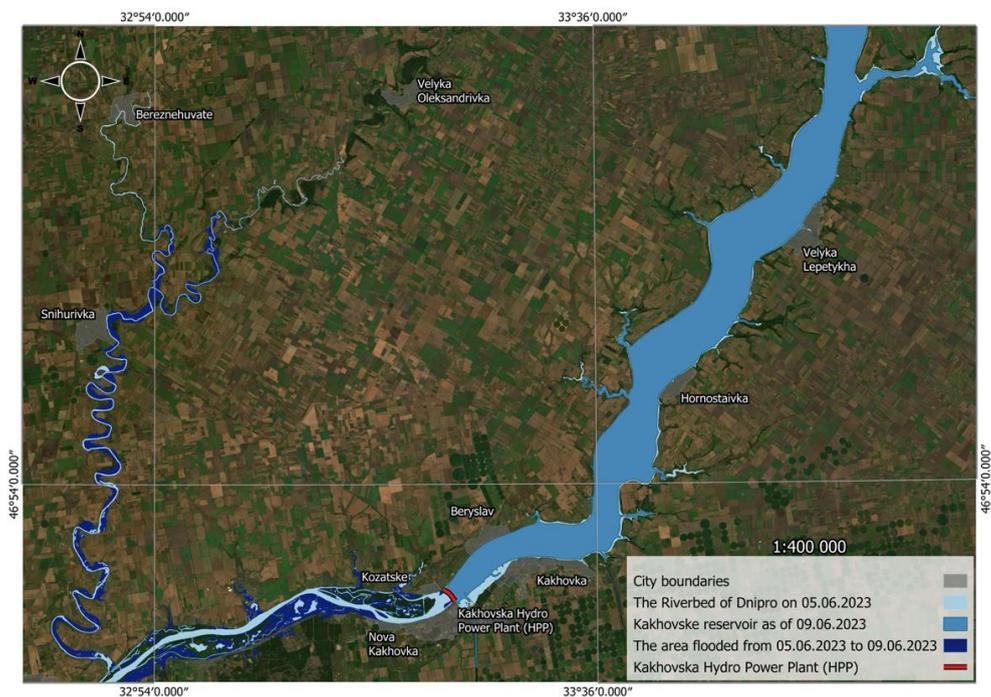
Difference in water mask for the upstream zone (geographical scope of water movement analysis) based on the satellite image from June 9, 2023

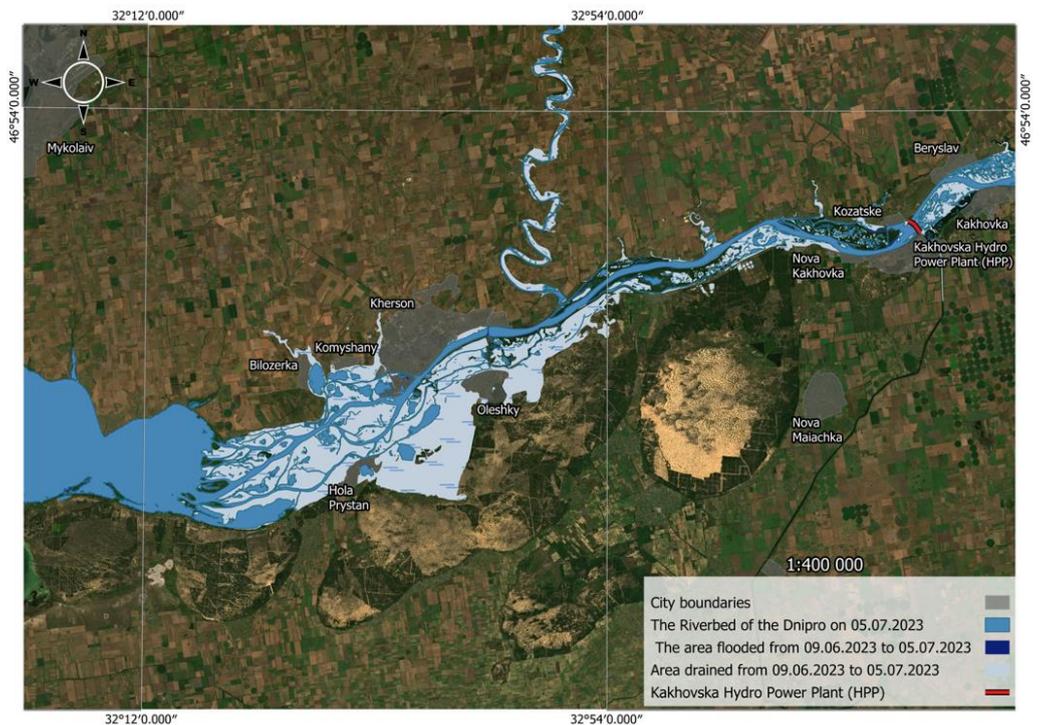
Difference in water mask for the downstream zone (geographical scope of water movement analysis) based on the satellite image from July 5, 2023

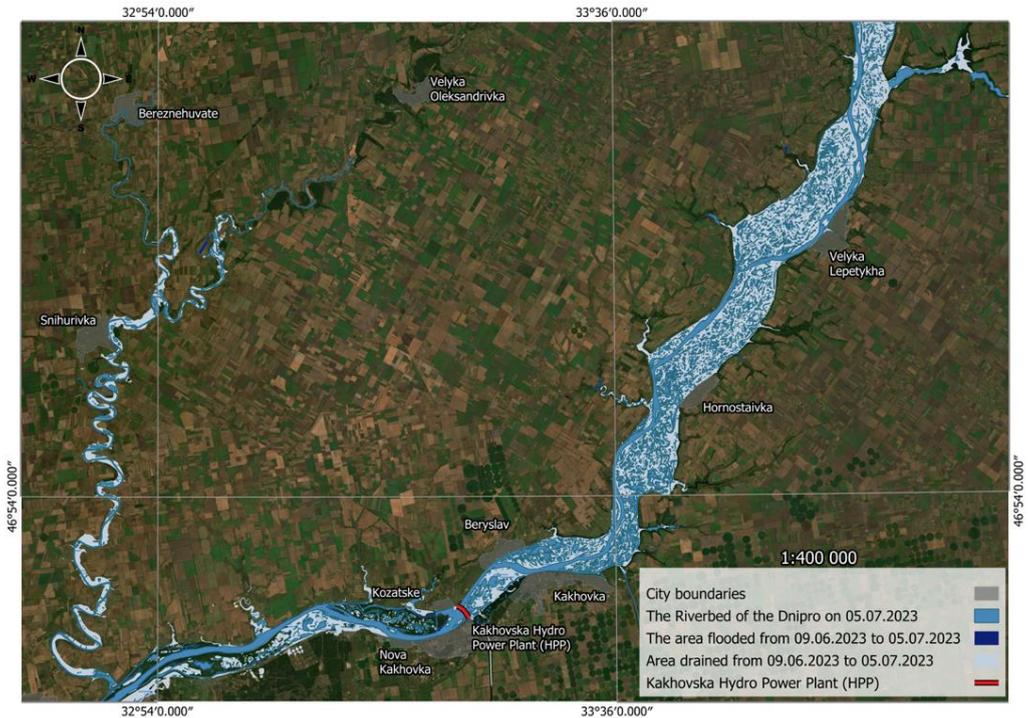
Difference in water mask for the upstream zone (geographical scope of water movement analysis) based on the satellite image from July 5, 2023

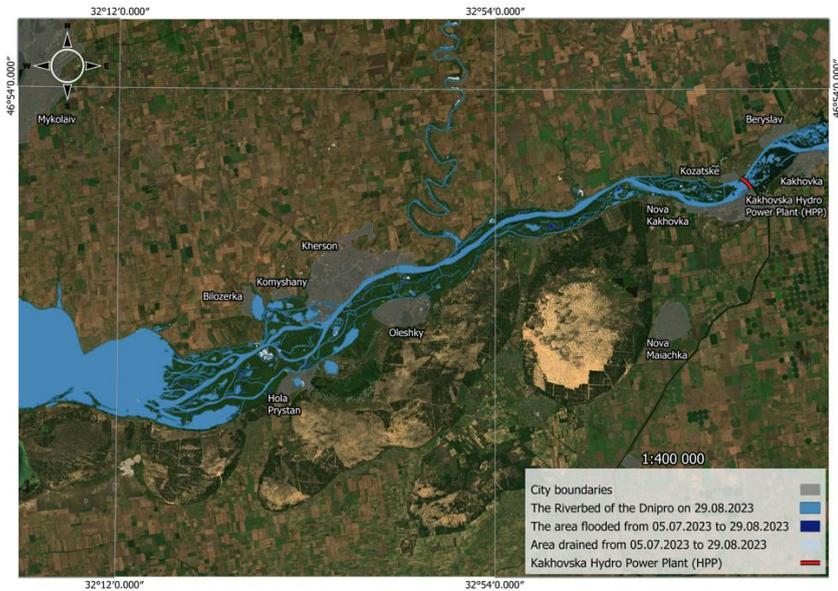
Difference in water mask for the downstream zone (geographical scope of water movement analysis) based on the satellite image from August 29, 2023

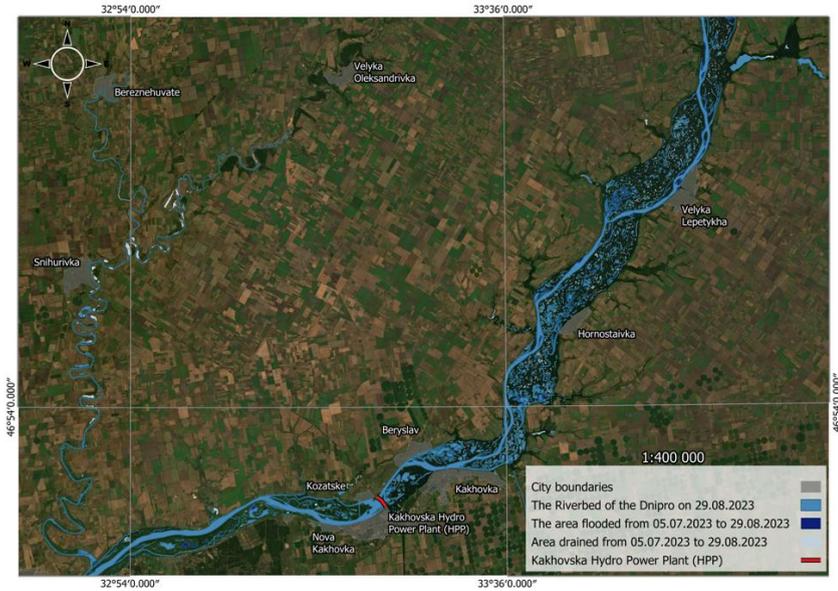
Difference in water mask for the upstream zone (geographical scope of water movement analysis) based on the satellite image from August 29, 2023

As previously noted, on August 29, 2023, nearly 3 months after the Dam’s collapse, 17.8368 km² of land in Mykolaiv and Kherson Oblasts remained flooded. A closer examination of the water levels in the downstream and upstream zones through mask comparison shows a significant decrease in the Inhulets and Dnipro Rivers and Dnipro Riverbed. A large, drained area is visible within the Kakhovka Reservoir itself, which will be further detailed in subsection 3.2 below.

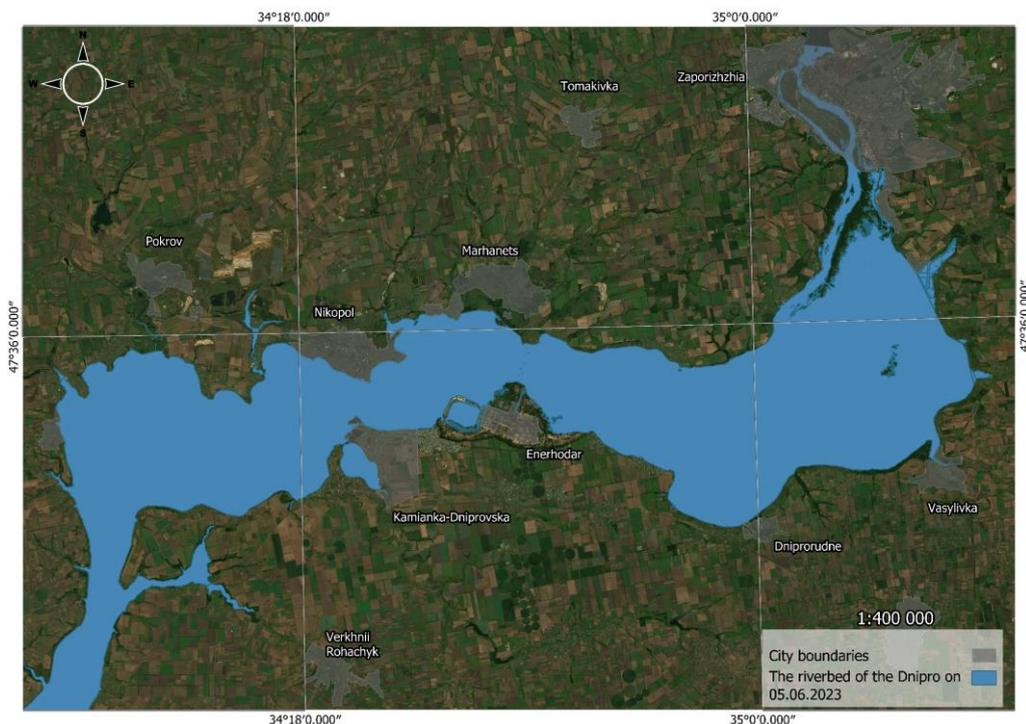
Water mask for the Kakhovka Reservoir (geographical scope of water movement analysis) based on the satellite image from June 5, 2023

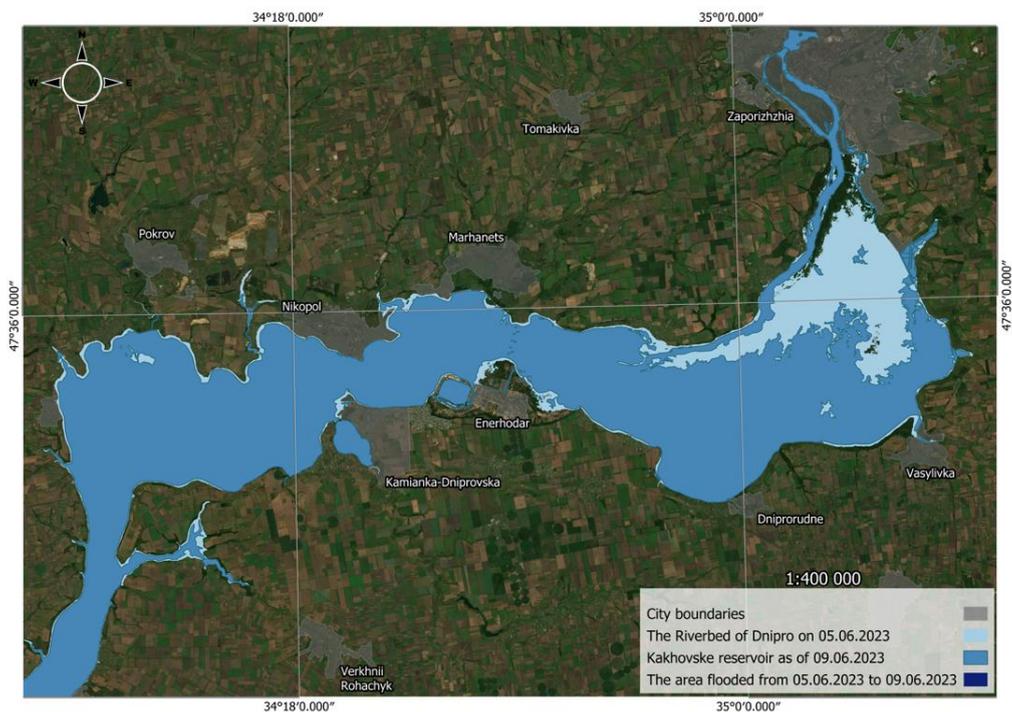
Difference in water mask for the Kakhovka Reservoir (geographical scope of water movement analysis) based on the satellite image from June 9, 2023.

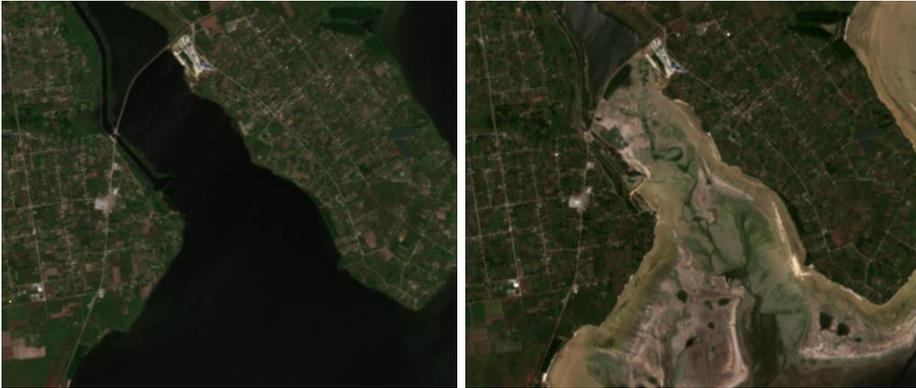
(i) The satellite imagery of the inlet to the canal near Marianske from the Kakhovka Reservoir on June 5, 2023 (left) and on June 18, 2023 (right). Source: Sentinel-2 L2A.²¹⁹

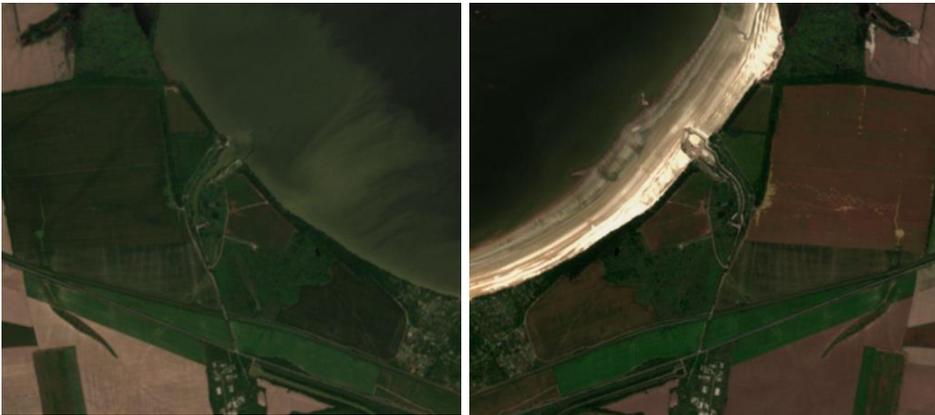
(ii) The satellite imagery of the inlet to the northernmost canal near Balky from the Kakhovka Reservoir on June 5, 2023 (left) and on June 20, 2023 (right). Source: Sentinel-2 L2A²²⁰

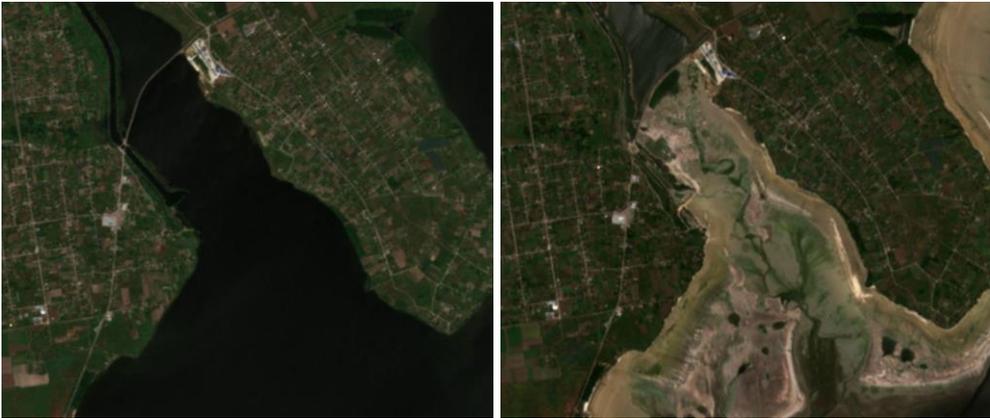
(iii) The satellite imagery of the inlet to the North Crimean Canal from the Kakhovka Reservoir on June 5, 2023 (left) and on June 18, 2023 (right). Source: Sentinel-2 L2A²²¹

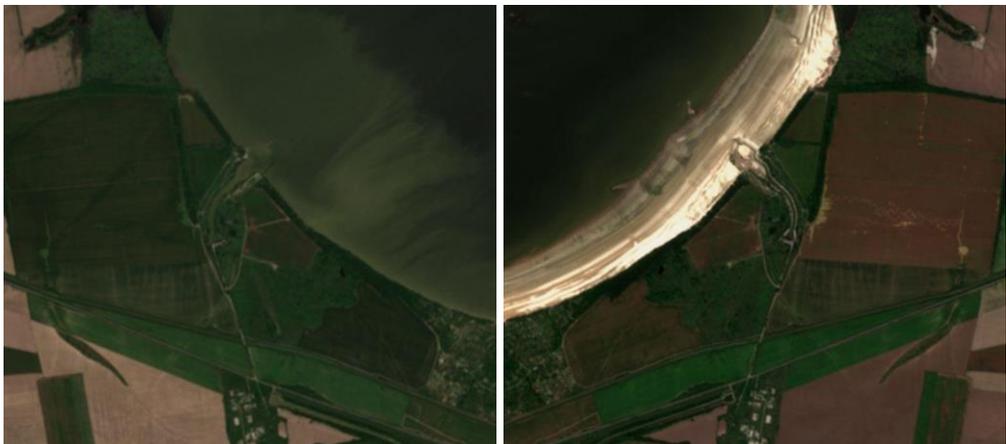
(iv) The satellite imagery of the inlet to the Kakhovskiy Canal from the Kakhovka Reservoir on June 5, 2023 (left) and on June 18, 2023 (right). Source: Sentinel-2 L2A²²²

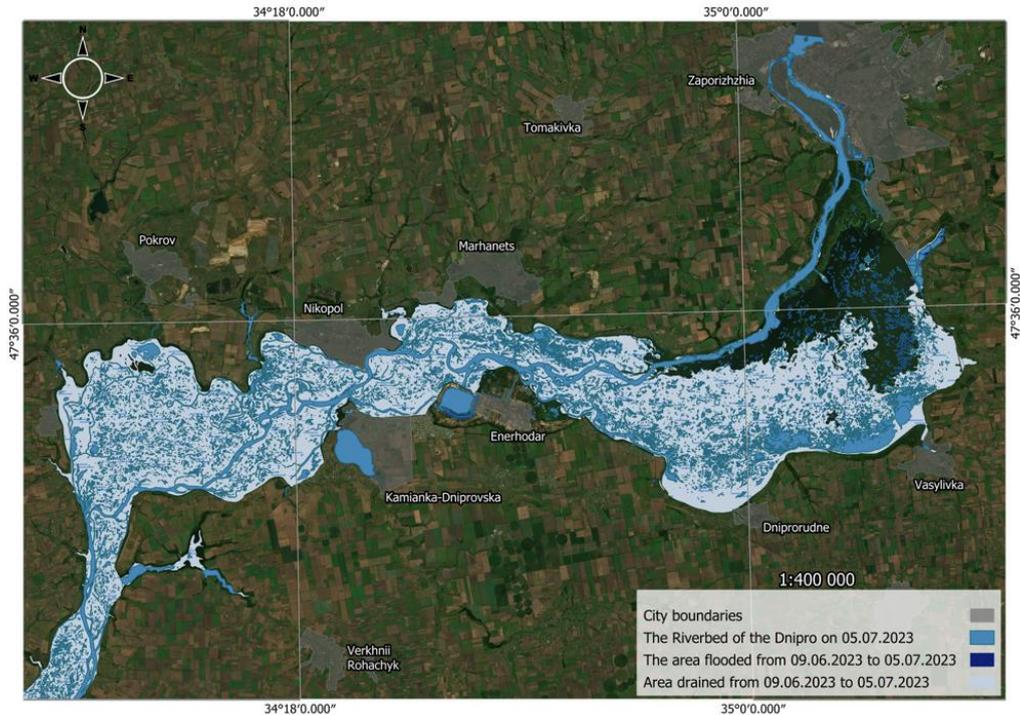
Difference in water mask for the Kakhovka Reservoir (geographical scope of water movement analysis) based on the satellite image from July 5, 2023

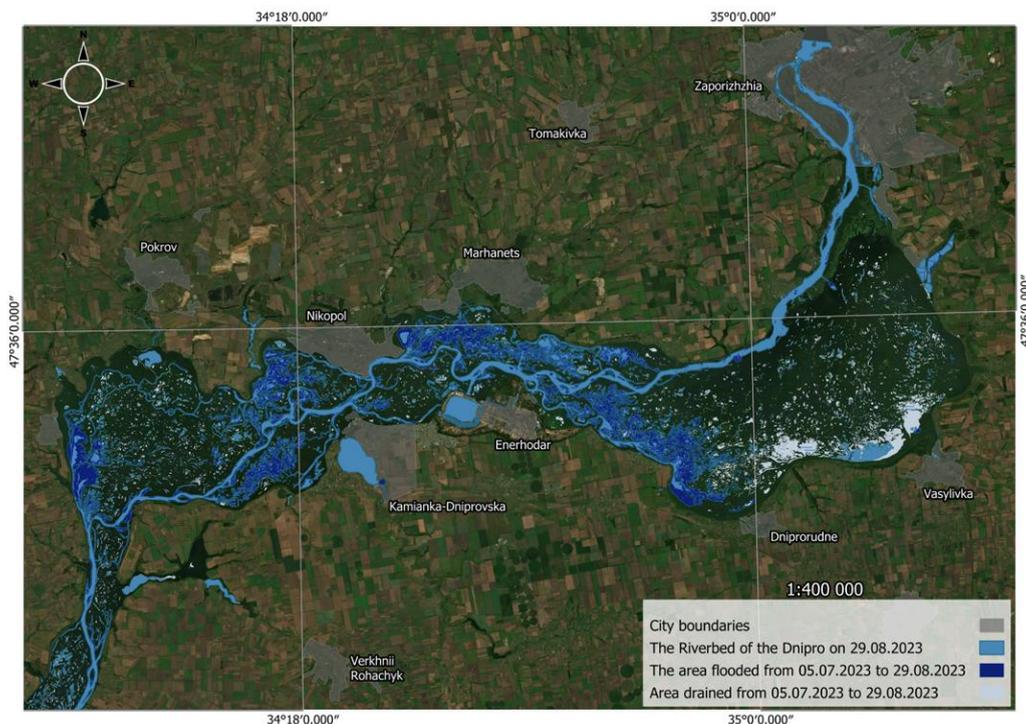
Difference in water mask for the Kakhovka Reservoir (geographical scope of water movement analysis) based on the satellite image from August 29, 2023

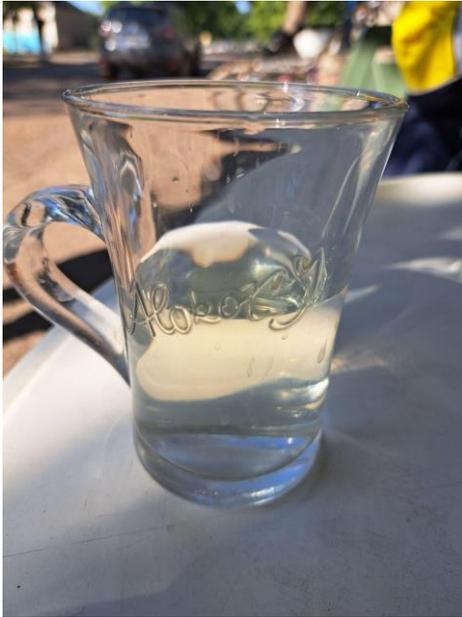
Oleksandrivka Village water quality after Kakhovka Dam collapse, photo by Tetiana

TH and PEJ received some accounts of the dire situation in a dozen settlements. Tetiana, a woman from Oleksandrivka Village in Dnipropetrovsk Oblast, recounted they used to enjoy clean, drinkable water. However, following the Dam explosion, the water quality deteriorated dramatically. *"After settling overnight, a substantial amount of sediment accumulates at the bottom of a bucket. This water, with a reddish tinge, unpleasant swampy odor, and surface film, is even rejected by our chickens,"* she describes.²⁹⁶

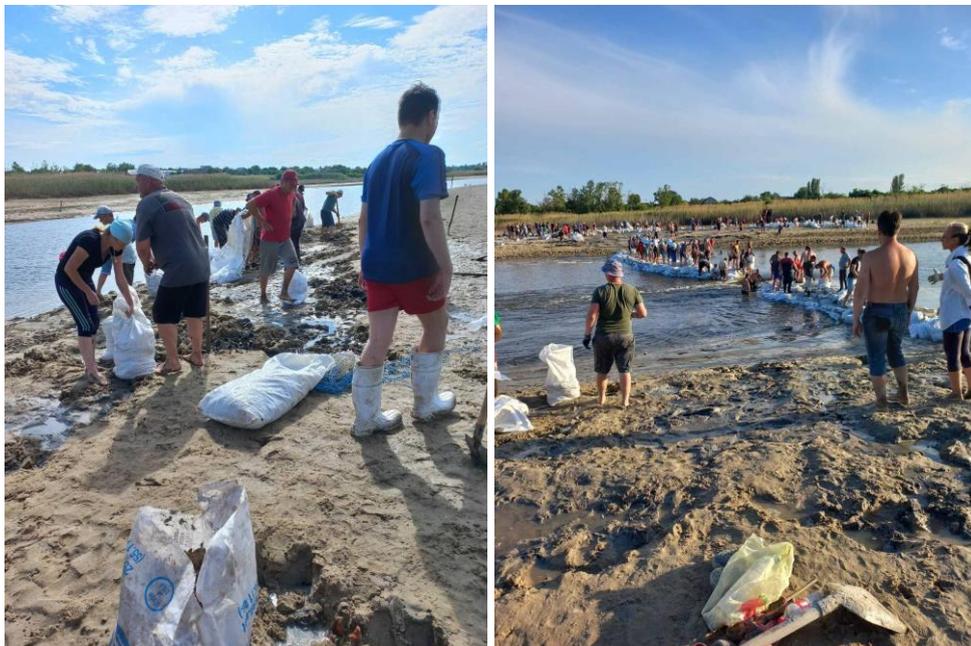
Construction of a self-improvised dam by locals, Kapulivka and Oleksiivka, Dnipropetrovsk Oblast, June 2023. Source: photo by TH and PEJ field reserchers

While some communities managed to preserve some water through local initiatives, such as building a self-improvised dam in the villages of Kapulivka and Oleksiivka,³⁰¹ or obtained temporary relief through the delivery of water and its storage in water tanks, the primary mitigation effort involves the construction of a new strategic pipeline.

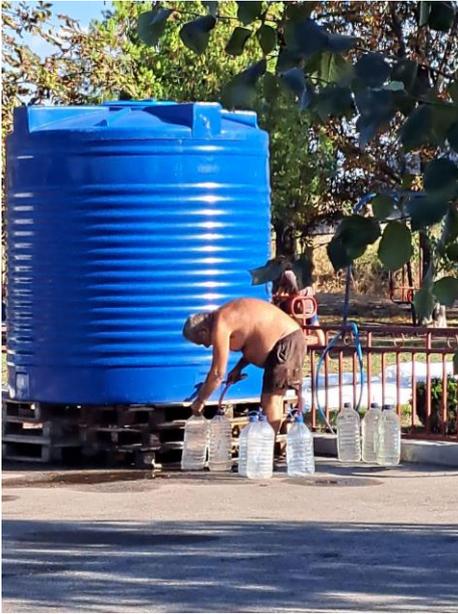
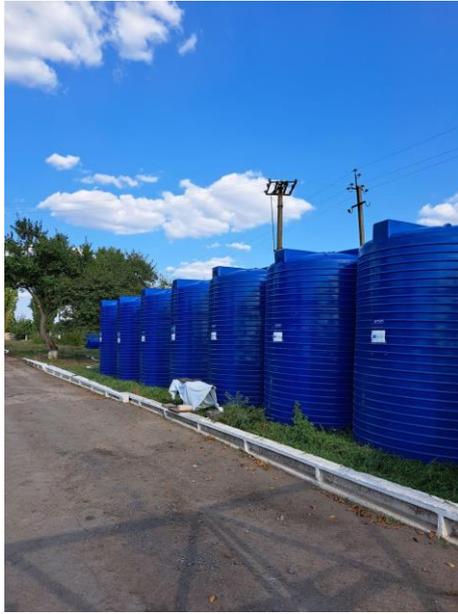
Water tanks for the affected communities in Kapulivka (left) and Nyva Trudova (right), Dnipropetrovsk Oblast. Source: photo by TH and PEJ field reserchers

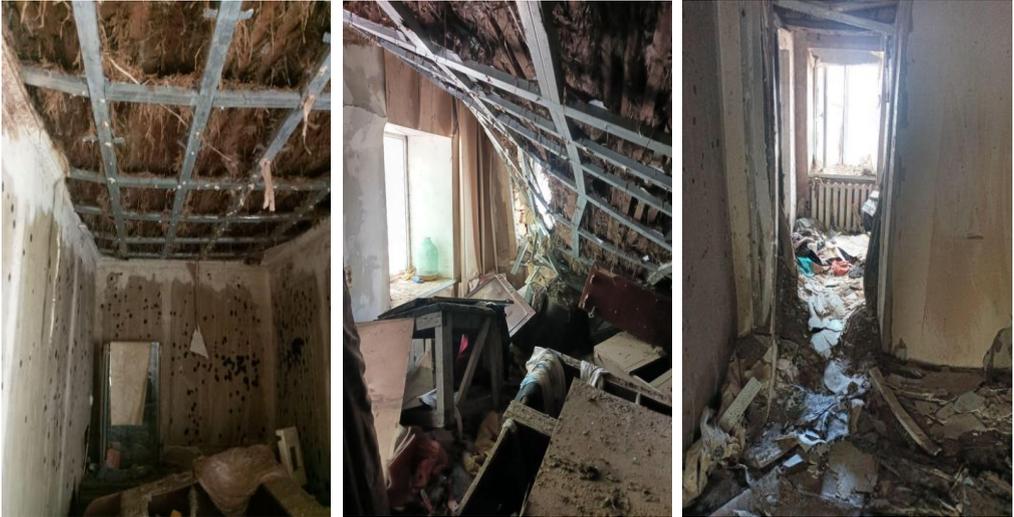
☞ *"I lost everything I had. There was mud everywhere, the furniture was swollen, and most of the things were damaged. To restore that house now, I don't know how much I need. It is beyond repair; it needs to be demolished and a new one built. It is now crumbling, the walls are cracked, and the ceiling has almost fallen into the house."⁸¹¹*

The house of Anna

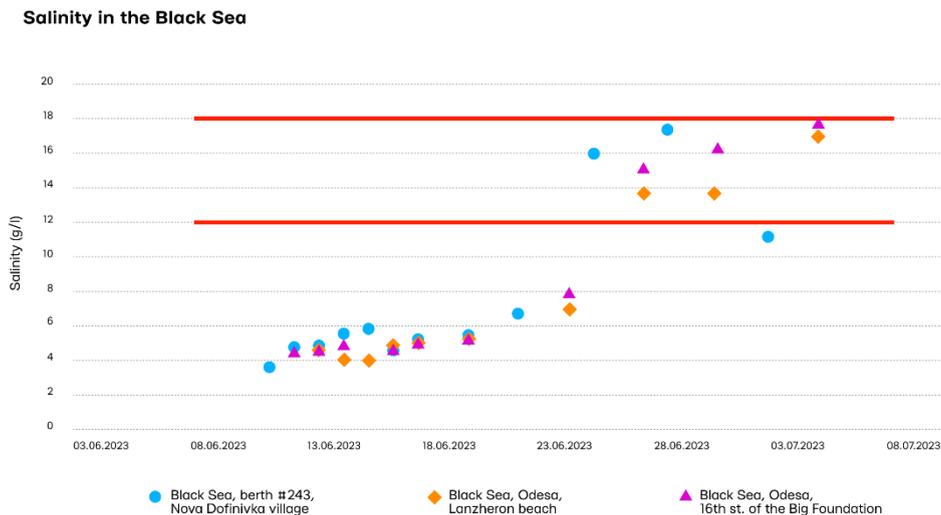
Salinity levels in the Black Sea from June 3, 2023, to July 8, 2023. Source: UNEP (2023) scale, created on the basis of State Agency of Water Resources data (2023)³³⁵

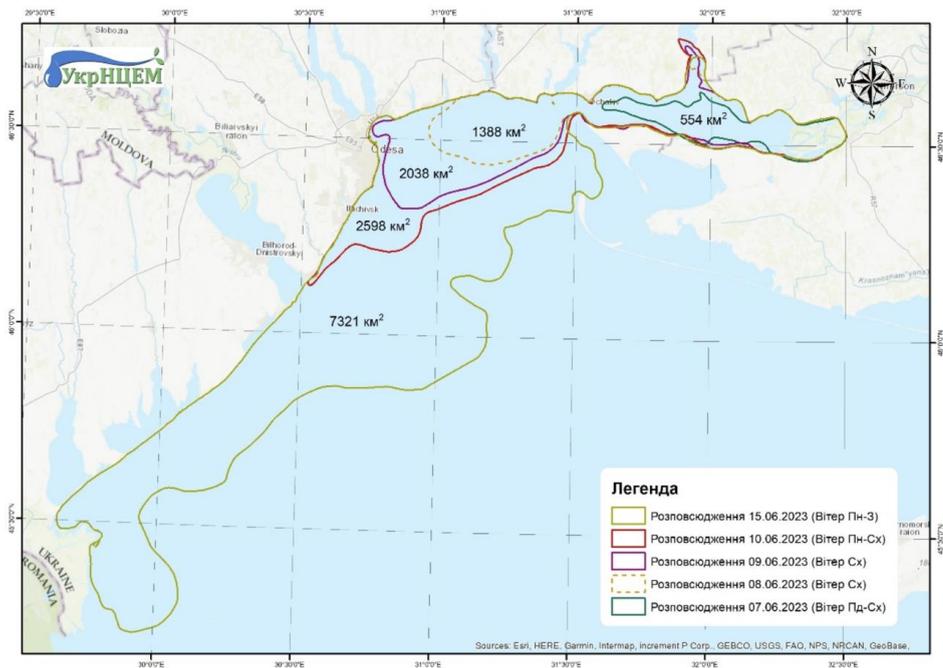
A map based on satellite imagery showing the timeline of the spread of contaminated waters to the Dnipro-Buh Estuary and the northwestern part of the Black Sea. Source: UkrSCES³⁴¹

The Institute of Marine Biology of the National Academy of Sciences of Ukraine (“Institute of Marine Biology of Ukraine”) reported a slightly lower volume of water spread as of June 15, 2023 – nearly 6,000 km² of contaminated seawater. They also visually highlighted the water spread to the coastline of other states.³⁴²

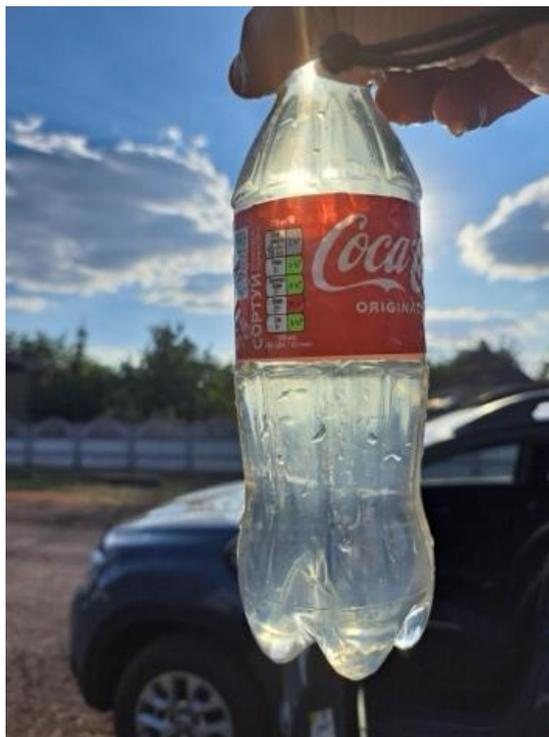
Tap water in a plastic bottle – the visual representation of the water turbidity level (the turbidity is high compared to the normal water quality) in Novoukrainske Village (Kryvyi Rih District, Dnipropetrovsk Oblast)³⁴⁵

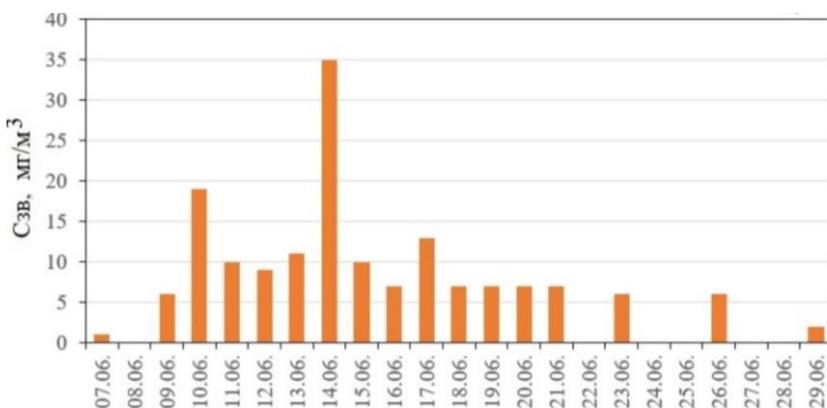
The concentration of suspended solids in the Black Sea. Source: UkrSCES, based on State Environmental Inspectorate data³⁶³

Regarding the Black Sea, seawater samples collected on June 10, 2023, by the State Environmental Inspectorate from 3 locations in the Odesa Oblast showed that the concentration of suspended solids exceeded standard limits by 1.1 to 1.6 times.³⁶⁰ Subsequent samples taken on June 13, 2023, in the same areas revealed that the accumulation of suspended solids had increased to 1.6 to 2.6 times the permissible levels.³⁶¹ From June 20, 2023, the concentrations of suspended solids had somewhat stabilized, yet fluctuations continued. By June 26, 2023, the concentrations of the suspended solids were above the norm in only one of 3 samples collected in the Black Sea.³⁶²

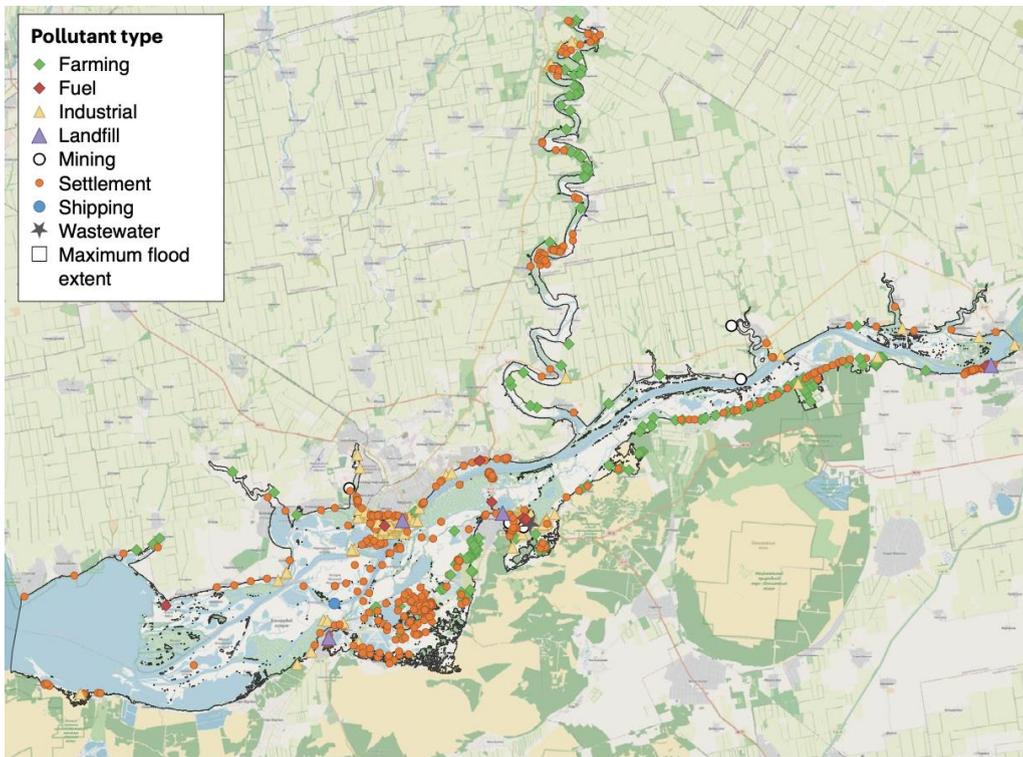
Located polluted sources within the maximum hydraulic flood zone of Kakhovka Dam breach mapped by UKCEH and HRW, based on the use of 23 geospatial datasets. Source: FDCO/OpenStreetMap³⁷²

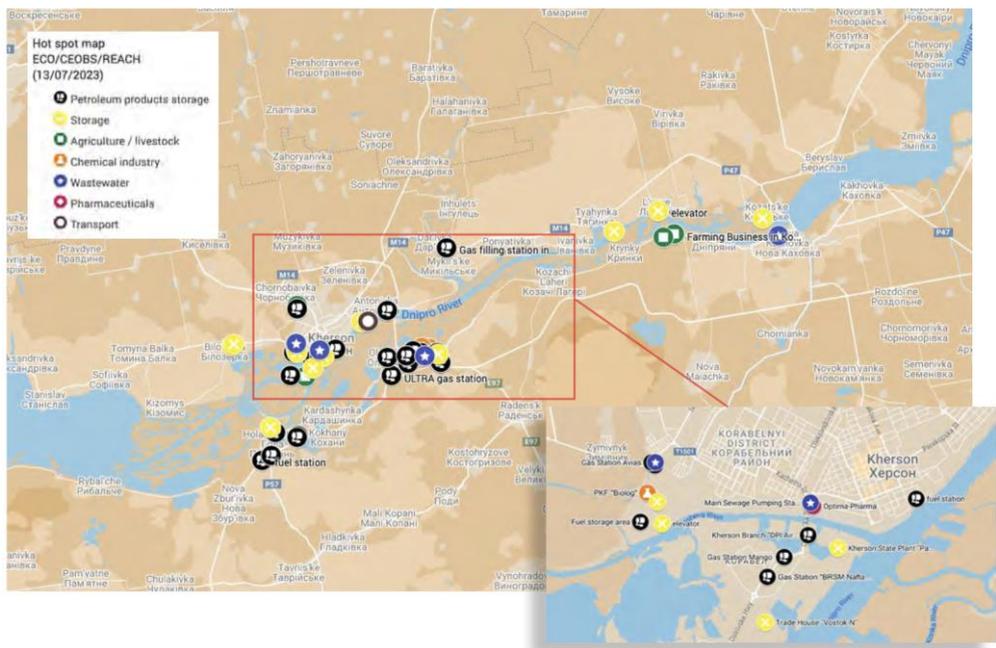
Map overview of the 54 potential pollution hotspots due to the Kakhovka Dam breach. Source: UNEP³⁷⁴

It is clearly evident on the abovementioned map that the Kherson City port area (sea and river), which served as a key storage site for oil, was one of the biggest water contamination hotspots. The Ministry of Environmental Protection and Natural Resources of Ukraine ("MEPNRU") reported that the Kherson Oil Depot in Port Naftohavan (46.60000753082153, 32.5484823427616) was affected by the water stream. However, it remains unclear what amount of oil, if any, was present at the refinery during the flooding.

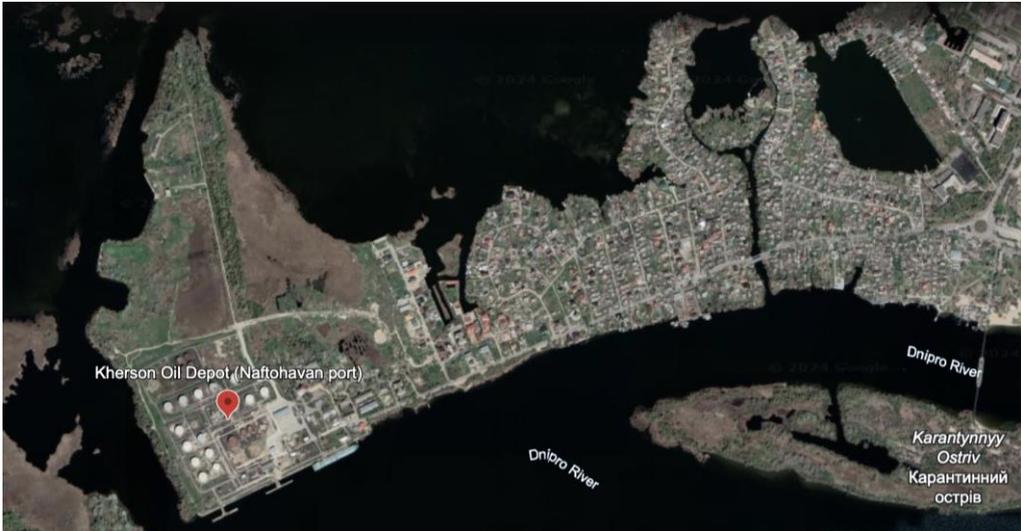
Satellite imagery of the Kherson Oil Depot in Port Naftohavan on April 25, 2022. Source: Google Earth

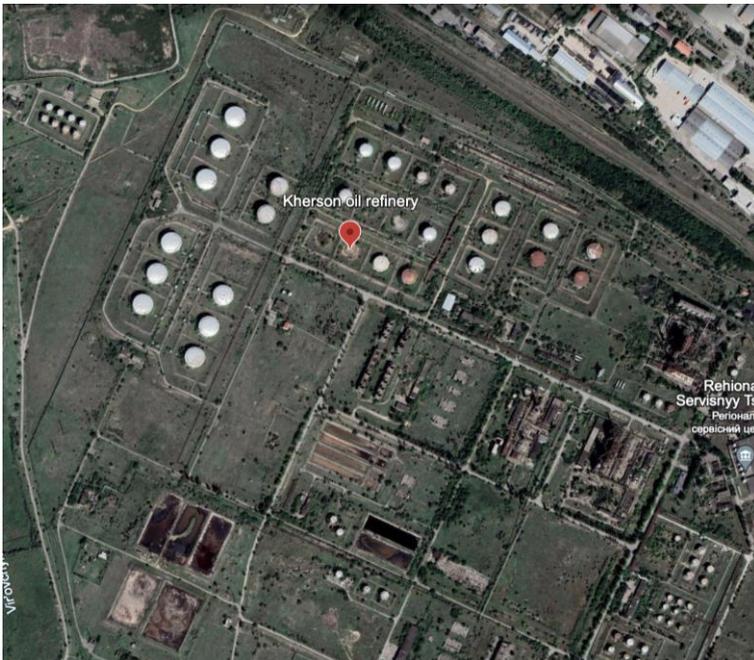
Satellite imagery of the Kherson Oil Refinery in Kherson on August 28, 2022.
Source: Google Earth

A potential oil pollution hotspot was also identified near the Kherson port area in the Korabelnyi District (46.4023, 32.3405) – specifically, the Kherson Oil Refinery. While pre-flooding satellite imagery shows that many huge fuel tanks were located at the site, it is unknown whether any oil was inside the tanks or whether their integrity was affected due to flooding. Moreover, the refinery does not clearly appear in the flooding zone mapped jointly by EOS, TH, and PEJ.

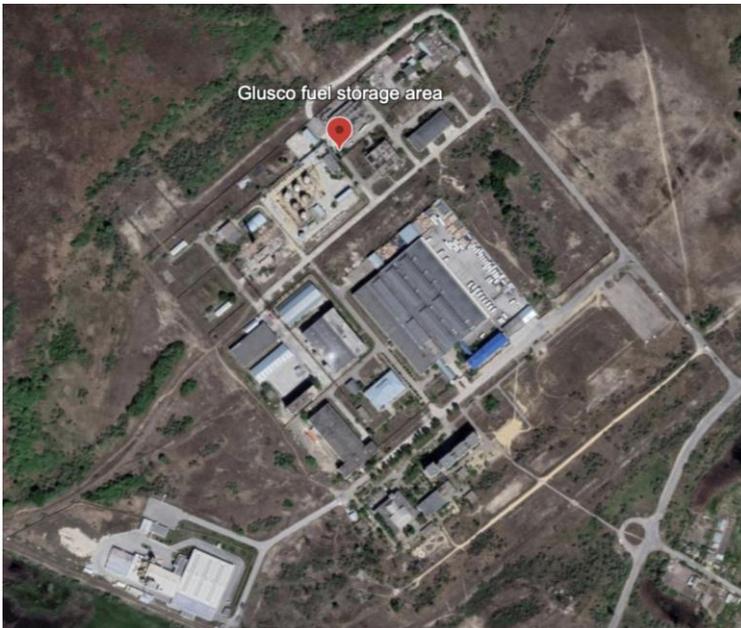
Satellite imagery of the Glusco fuel storage area in Oleshky on 08.05.2022.
Source: Google Earth

As it was mentioned in Section III, the left bank of the Kherson Oblast is geographically situated lower than the right bank, which is why there was more intense flooding of the left bank. Among the 15 gas stations identified in the flooding zone by MEPNRU, 4 were located on the Russian-occupied left bank, in Oleshky.³⁷⁵ At later stages, several other potential contamination sites were found to be inundated on left bank, including oil refineries and oil storage sites in addition to gas stations. One of the many identified potential pollution hotspots was the Glusco fuel storage area in Oleshky (46.625226, 32.789267). While the pre-flooding satellite imagery demonstrates several oil tanks at the site, once again, it remains uncertain whether any oil was present there or if the integrity of these tanks was affected by the water stream.

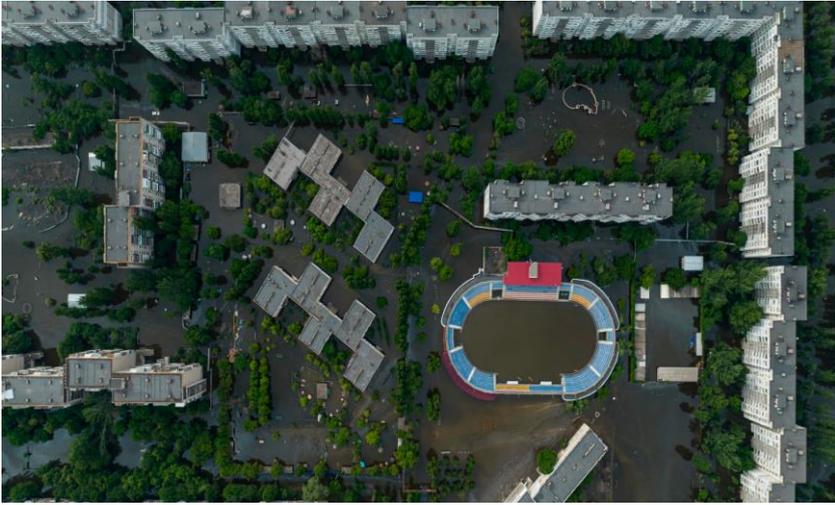
An aerial view of a flooded neighborhood in Nova Kakhovka showing polluted water. Source: AP NEWS/Keystone.³⁷⁶

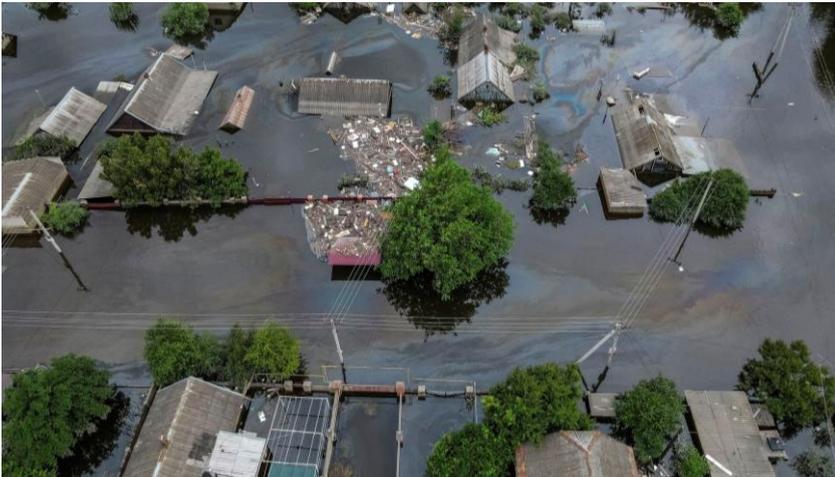
An aerial view of a flooded neighborhood in Kherson (right), showing some oil slicks in the water. Source: REUTERS/Inna Varenysia³⁷⁷
