SUBMERGED:

**Study of the Destruction
of the Kakhovka Dam and
Its Impacts on Ecosystems,
Agrarians, Other Civilians,
and International Justice**

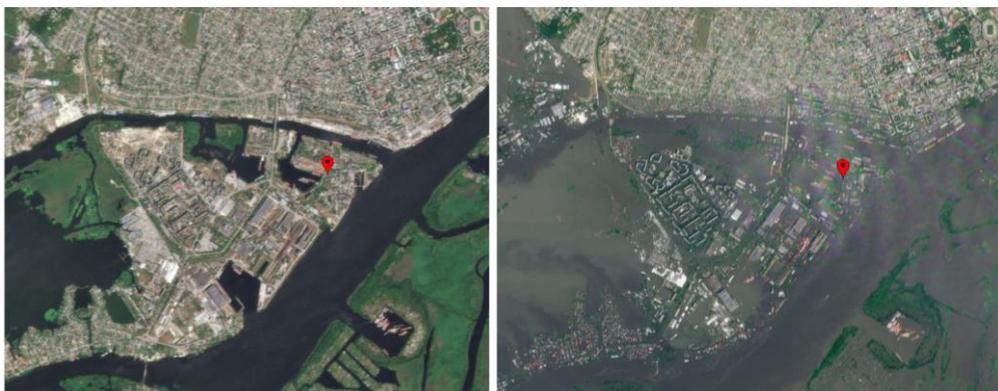
Satellite imagery of the Pallada Shipyard in Kherson on June 5, 2023 (left) and on June 7, 2023 (right). Source: Planet Labs³⁷⁸

Another significant source of water pollution was the inundation of chemical industry facilities. Following the Kakhovka Dam breach, MEPNRU reported that due to the flooding, liquid fertilizer storage containers (urea-ammonia mixture) at the Limited Liability Company ("LLC") Pallada Shipyard shipbuilding enterprise (46.62155441257991, 32.60343736136591) in the Kherson City port area were damaged, resulting in the release of chemicals into the environment. On February 23, 2022, 3470.68 tons of fertilizers were stored at the site, which might have entered the water (Dnipro River) after the inundation.

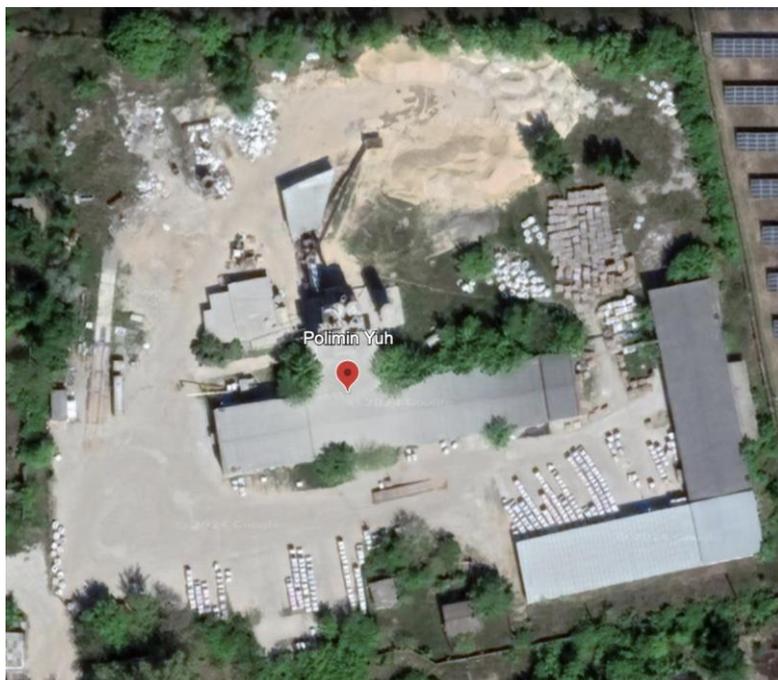
Satellite imagery of the Polimin-Yuh private enterprise in Oleshky on May 8, 2022.
Source: Google Earth

enterprise as a “high-risk” source of water contamination and reported that the facility experienced flooding up to a maximum depth of 5 meters.³⁸⁰

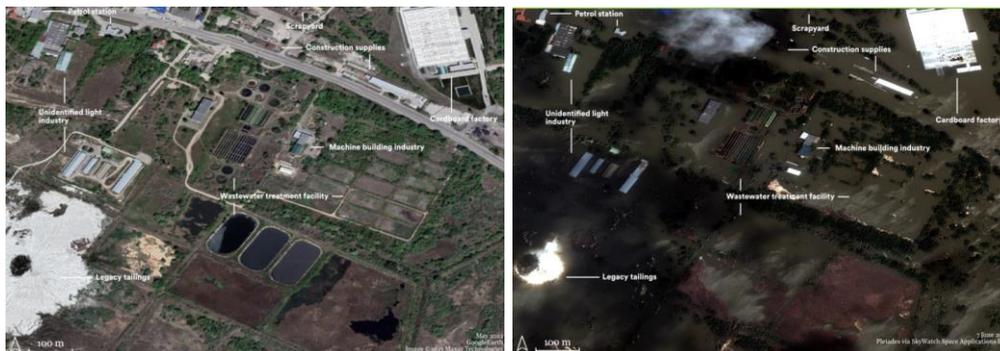
Satellite imagery of the Oleshky wastewater treatment in May 2022 (top image) and on June 7, 2023 (below), after the flooding. Source: CEOBS³⁸⁶

The sewage treatment facilities flooded by the breach of the Kakhovka Dam were a key contributor to the water pollution. One potential hotspot was the Oleshky wastewater treatment plant on the left bank of Kherson Oblast (46.622327, 32.769576).

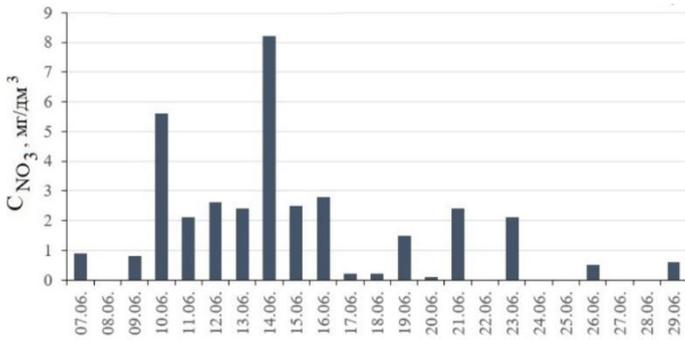
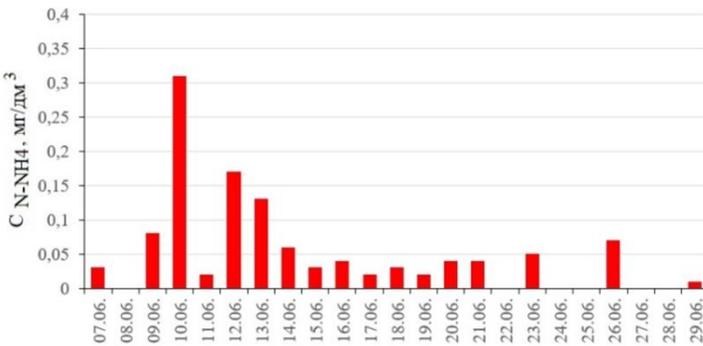
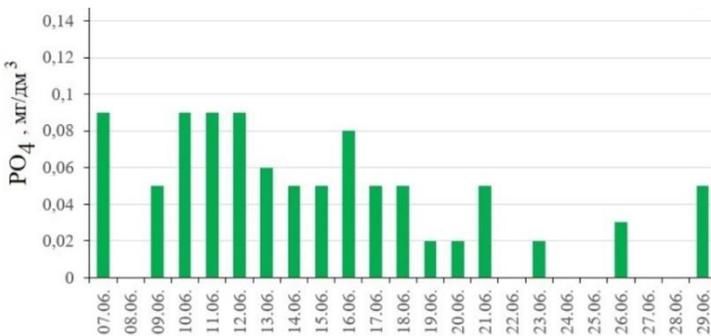
The concentration of (a) nitrates (NO₃), (b) ammonium (N-NH₄), and (c) phosphates (PO₄) in the area of Langeron Beach (Odessa City) in June 2023. Source: State Environmental Inspectorate data⁴¹³

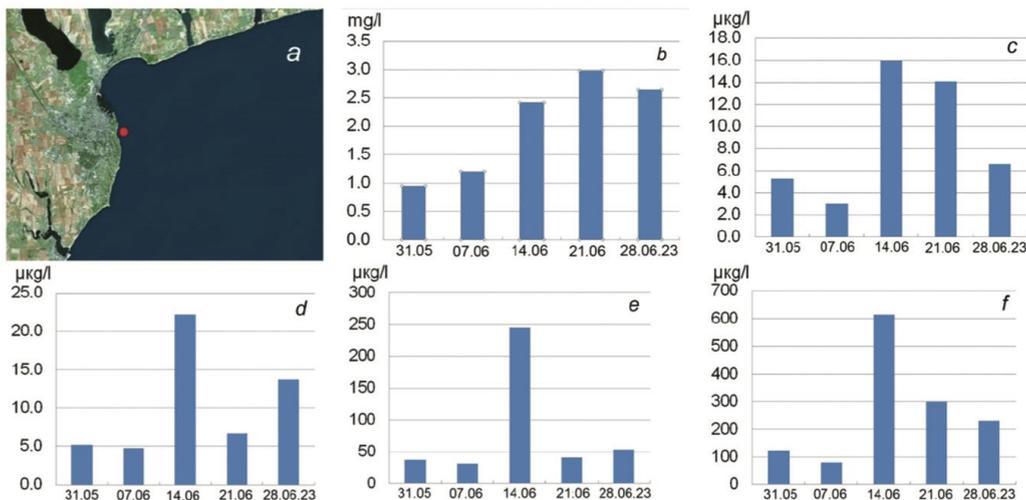
The concentration of (c) phosphates (PO_4), (d) nitrites (NO_2), (e) ammonium (NH_4), and (f) silicate (SiO_4) in the Black Sea near Odesa City yacht club in June 2023. Source: UkrSCES⁴¹⁴

Similarly, from June 8 through June 17–18, 2023, UkrSCES recorded an increased concentration of biogenic compounds in northwestern part of Black Sea, namely phosphates (PO_4), nitrites (NO_2), ammonium nitrogen (NH_4), and silicate (SiO_4) concentrations.

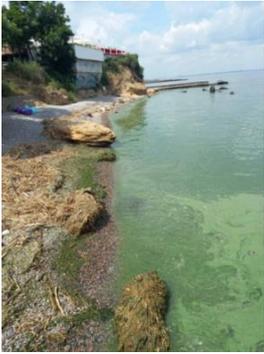
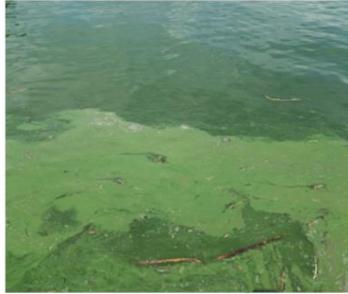
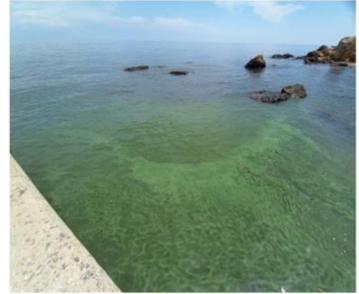
(Micro)algal bloom in the Gulf of Odesa as of June 14, 2023. Source: UkrSCES⁴²⁰

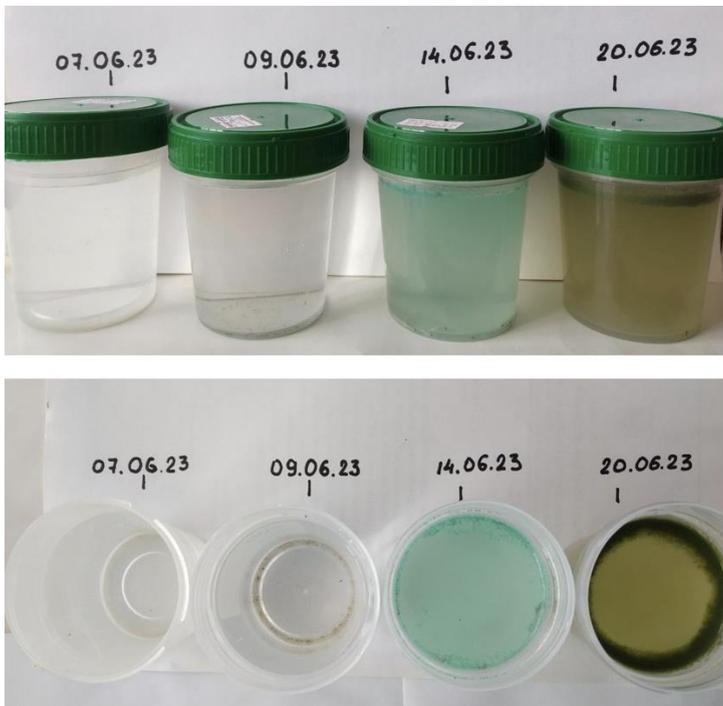
Black Sea water samples showing the volume of algae blooms throughout June 2023, after the breach of the Kakhovka Dam. Source: UkrSCES⁴²³

The concentration of Chlorophyll-a, which is the indicator of the algal bloom in water, reached critical levels during mid-June 2023. While the standard average index of Chlorophyll-a for the northwestern part of the Black Sea is 1.2 mg/m², on June 15, 2023, the index doubled, according to the Institute of Marine Biology of Ukraine. On top of that, in some parts of the Black Sea, located downstream of the river waters from the Dnipro-Buh Estuary, the Chlorophyll-a index was over 100 mg/m², which exceeded the norm by more than 90 times.⁴²⁴ UkrSCES reported that the satellite imagery from June 24, 2023, indicated an intensive algal bloom in the northwestern part of the Black Sea, spreading to the waters of Romania, Bulgaria, and partially Turkey.⁴²⁵

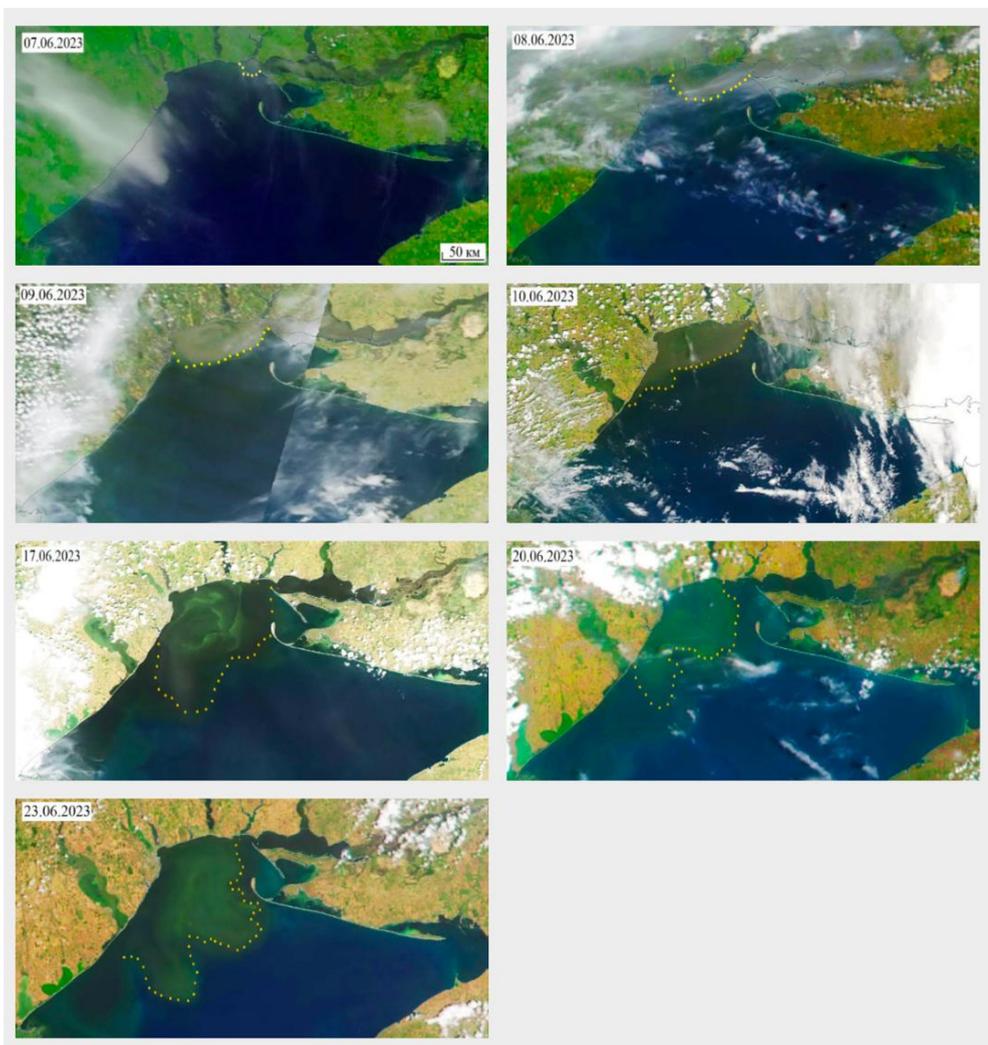
Processed satellite imagery of the northwestern part of Black Sea, showing the water spread from Dnipro-Buh Lyman (estuary) to the northwestern part of Black Sea⁴²⁶

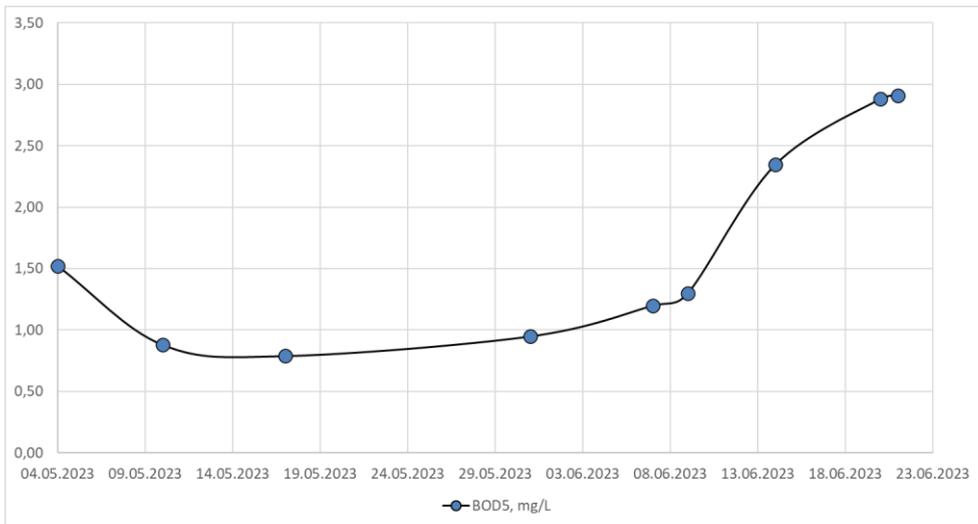
Biochemical oxygen demand (BOD5) index in the Gulf of Odesa (northwestern part of Black Sea) on a timeline scale. Source: UkrSCES.⁴³¹

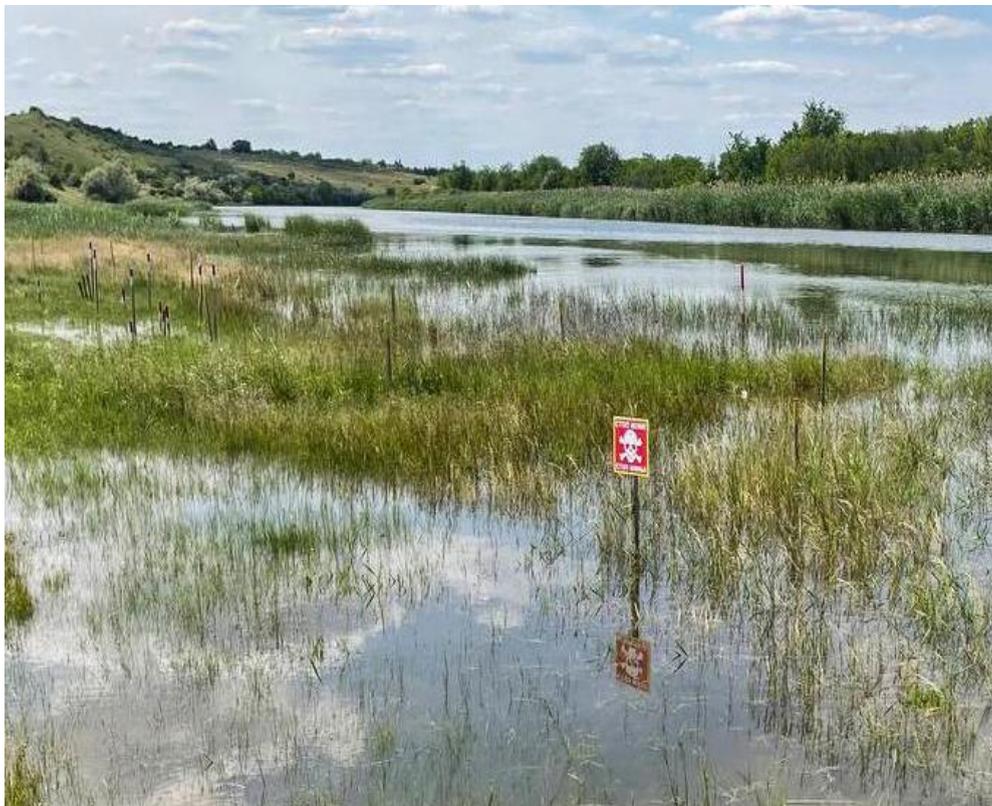
Submerged minefield in Kherson Oblast due to the Kakhovka Dam breach. Source: The HALO Trust⁴⁴⁶

flooded.⁴⁴⁷ The HALO Trust, an organization involved in the demining of the right bank of the river controlled by Ukraine, reported the complete flooding of at least 3 minefields in Mykolaiv Oblast, while the total number of previously found mines in the region was 5,000 units, including 464 on the riverbanks.⁴⁴⁸ The HALO Trust asserted that the water stream arriving from the Kakhovka Reservoir was powerful enough to dislodge the land mines, and, in certain circumstances, cause 10-kg anti-vehicle mines to detonate.⁴⁴⁹ Already on the first day of the flooding, there was public footage of floating landmines detonating.⁴⁵⁰ Similarly, on June 8, 2023, the Ukrainian authorities and military command reported floating landmines and unused ordnance near the shores of the Odesa Oblast.⁴⁵¹ In its analysis, UNEP also reported on the dislodging of land mines but emphasized that, compared to anti-vehicle mines, it is unlikely that anti-personnel mines were dispersed because they are expected to remain in place, covered by sediment or soil.⁴⁵²

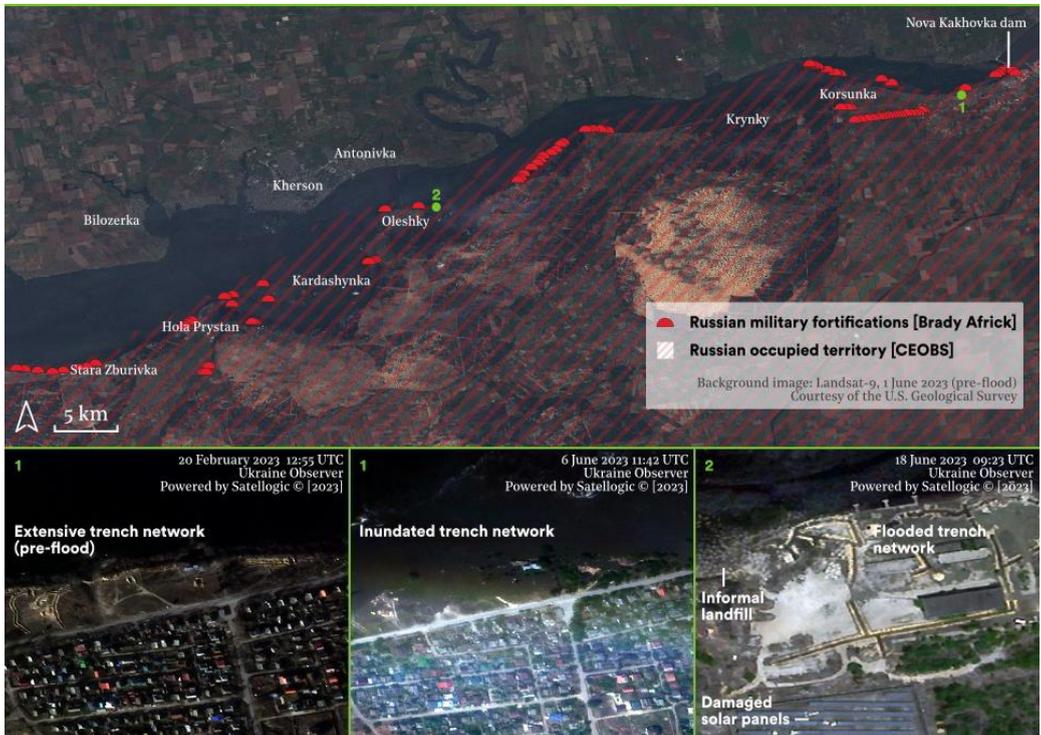
Satellite Imagery of flooded Russian trench work on the left bank of Dnipro.
 Source: CEOBS, July 2023⁴⁵³

As previously stated, the floodwater inundated a wider area on the left bank than on the right bank. Within these affected territories, many fortified positions and trenches built by the Russian military on the shore were washed away, including mines, ammunition, and other military equipment. According to the Conflict and Environment Observatory (“CEOBS”), among 117 military objects, including trenches, recorded on the left bank of the Dnipro River, 47 were identified as

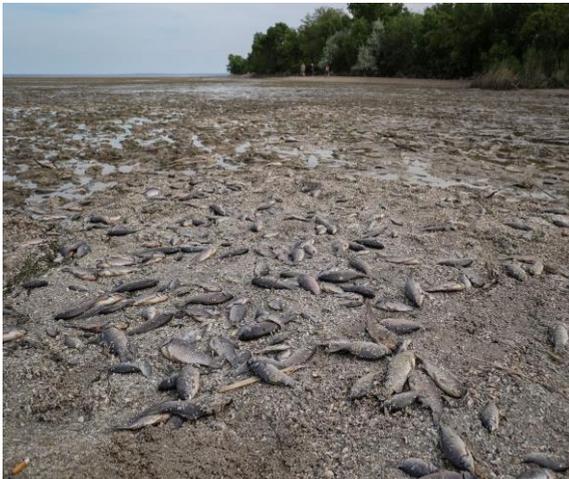
1 - Dead fish are seen on the drained bottom of the Nova Kakhovka Reservoir after the Dam breached in the village of Marianske in Dnipropetrovsk Oblast, Ukraine, June 7. REUTERS/Sergiy Chalyyi ⁴⁸⁰

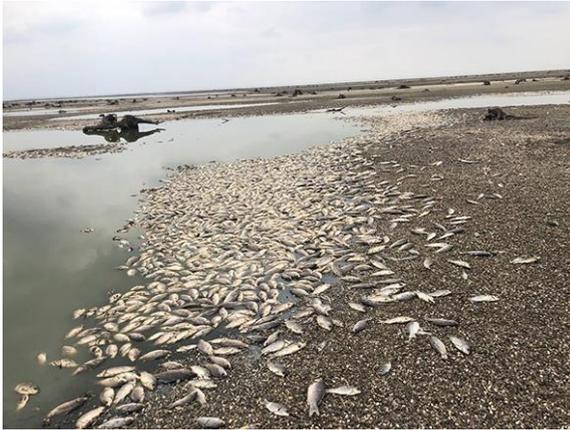
2 - Image of dead fish after drainage of the Kakhovka Reservoir published by the Zaporizhzhia Fisheries Patrol on June 15, 2023, near the village of Lysohirka, near Zaporizhzhia⁴⁸¹

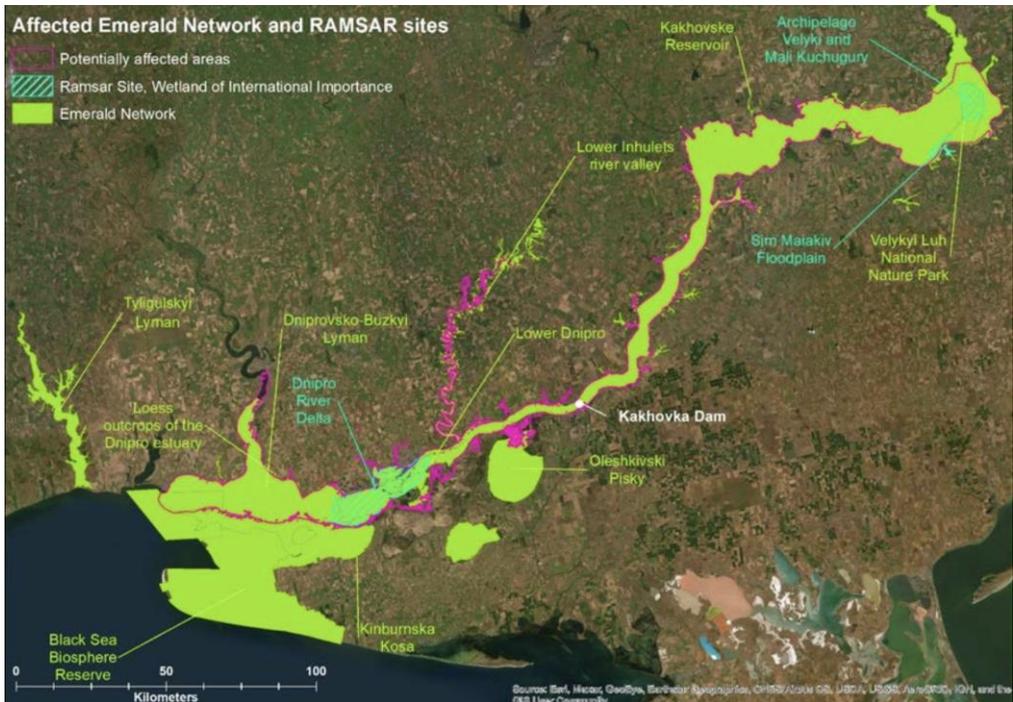
Map showing the effect of floodwaters on the environment. Potentially affected areas derived from UNOSAT pre-flood/flooded water extents and digitized pre-flood Reservoir boundaries. Emerald Network and Ramsar site boundaries from The World Database on Protected Areas⁴⁹⁷

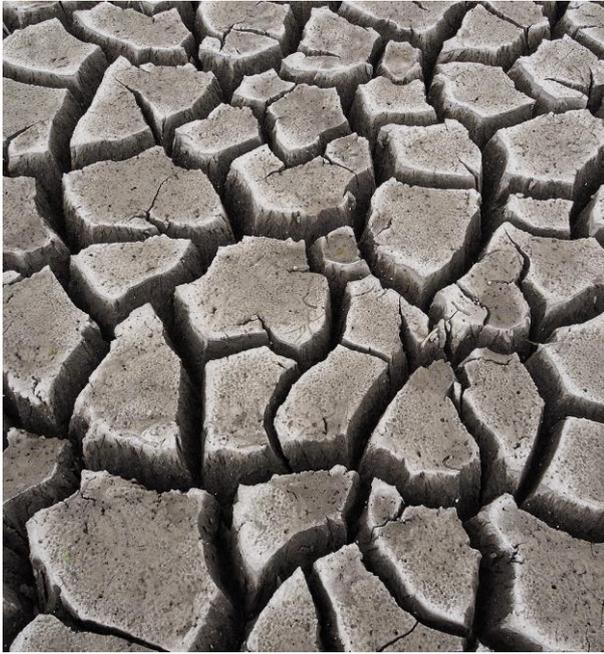
Photos of the dried-up bottom of the Kakhovka Reservoir published by the Ukrainian Nature Conservation Group on July 12, 2023⁵³⁷

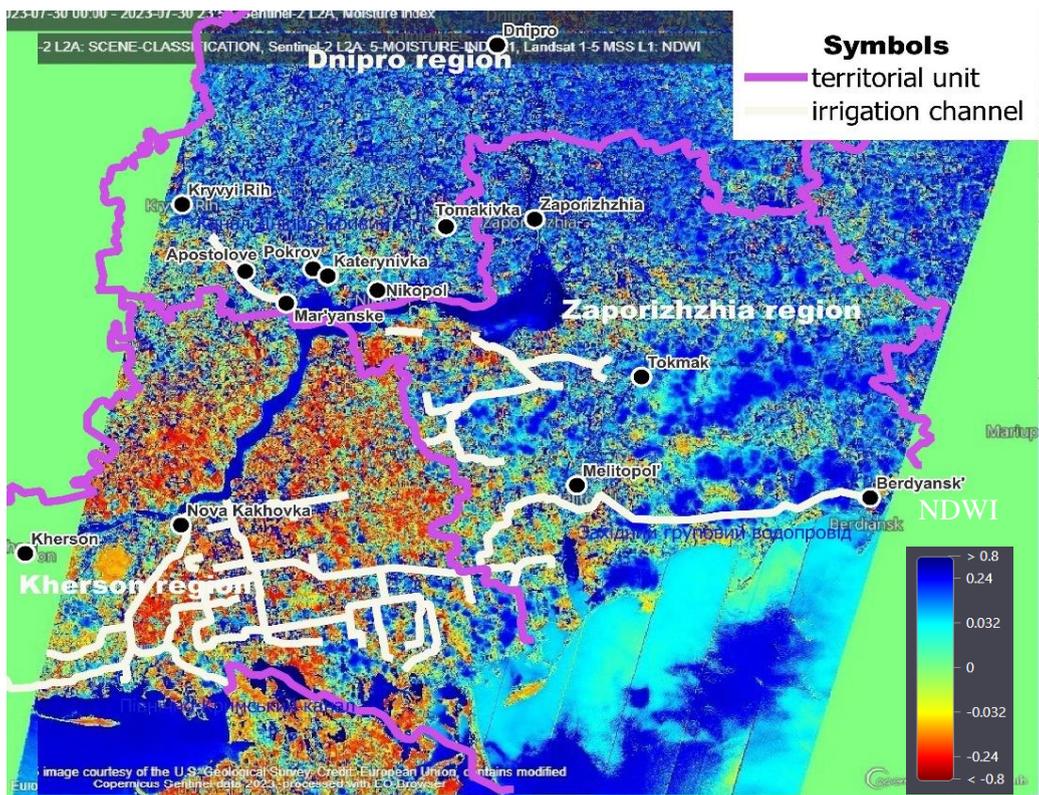
a - Analysis of the subsurface soil moisture content within the areas adjacent to the Kakhovka Reservoir for the period July 2020⁵⁴⁰

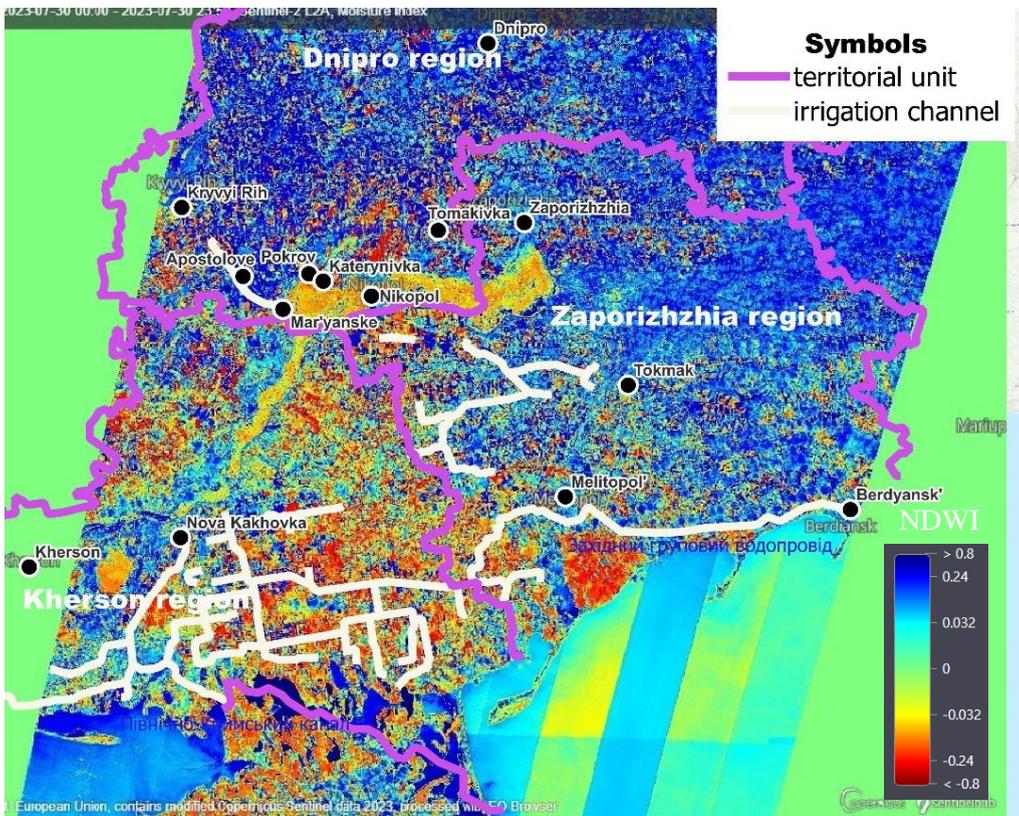
b - Analysis of changes subsurface soil moisture content within the areas adjacent to the Kakhovka Reservoir as a result of the Kakhovka Dam destruction, for the period July 2023⁵⁴¹

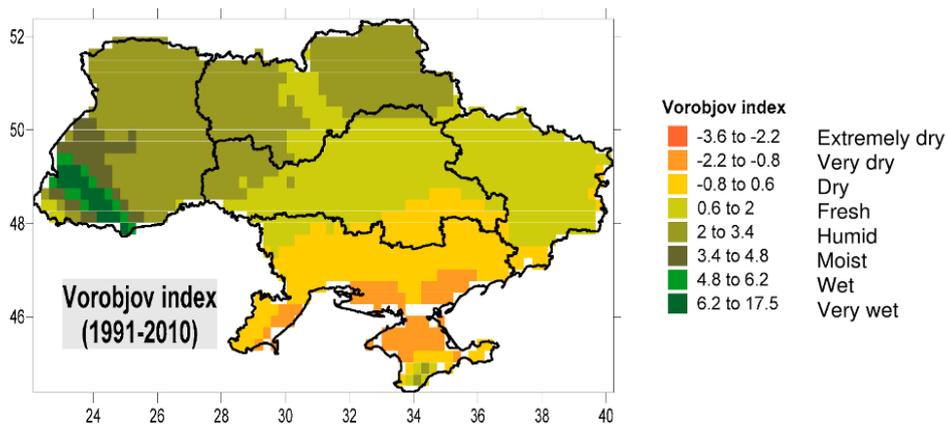
The presented map indicates the locations of the most drought-prone areas. Drought severity here is measured using the Vorobyov Index.⁵⁹⁹

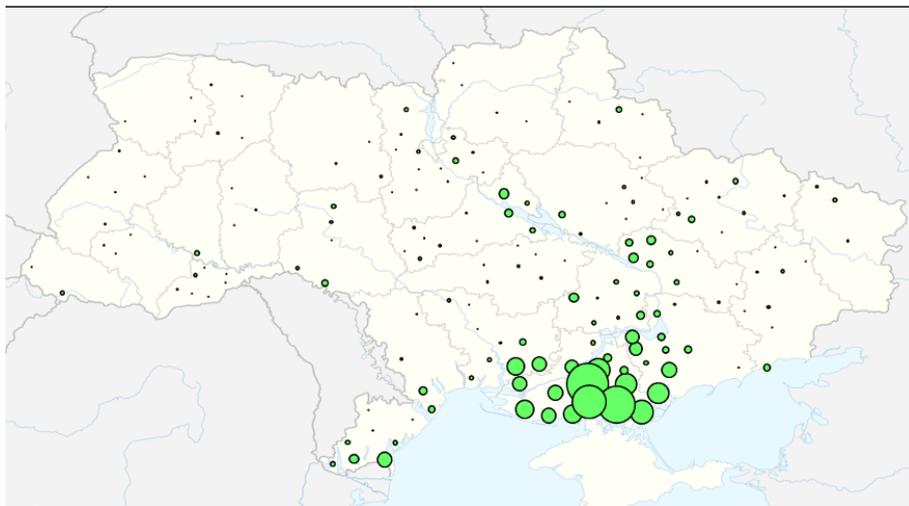
Area of irrigation by districts (2018-2021 average)

It is precisely in these drought-prone zones in which the majority of irrigation systems are located.⁶⁰⁰

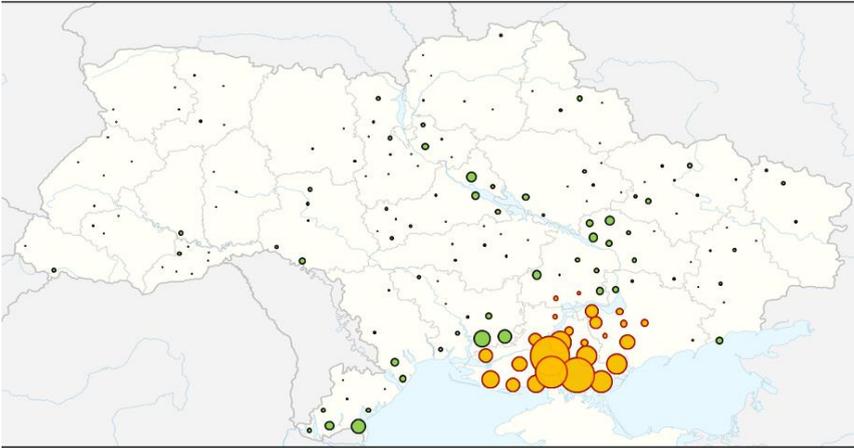
Area of irrigation by districts (2018-2021 average)

Before the full-scale invasion of the Russian Federation in February 2022, Ukraine had around 379 thousand hectares of croplands depending on the irrigation. 78% (297 kHa) of those lands depended on the Kakhovske Reservoir.⁶⁰³

● Depending on other water supply ● Depending on Kakhovske reservoir

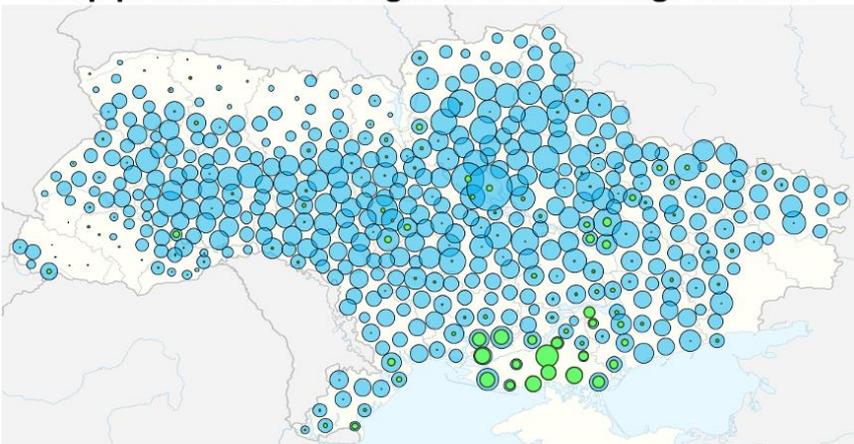
Crop production on irrigated and not irrigated land

As you can see, for Kherson and the south of Zaporizhzhia Oblasts, the Kakhovka irrigation system was critical to total crop production:⁶⁰⁴

● Irrigation-Independent Production kMT ● Irrigation-dependent Production kMT

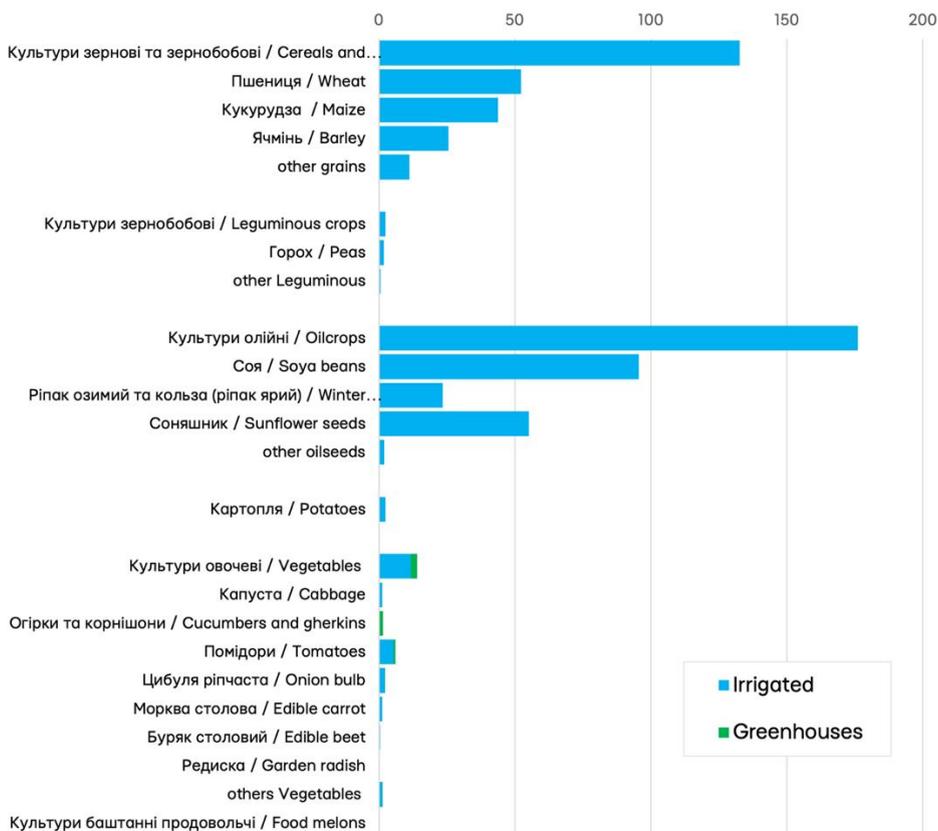
Zaporizhzhya, Dnipropetrovsk and Kherson Irrigation dependent Harvested Area (kHa)

The Kakhovka Reservoir irrigation system covered 3 regions: Zaporizhzhia, Dnipropetrovsk and Kherson.⁶⁰⁵ To evaluate potential losses, we analyzed crops cultivated with the aid of irrigation. Statistics on the irrigation dependent harvested areas are illustrated below:⁶⁰⁶

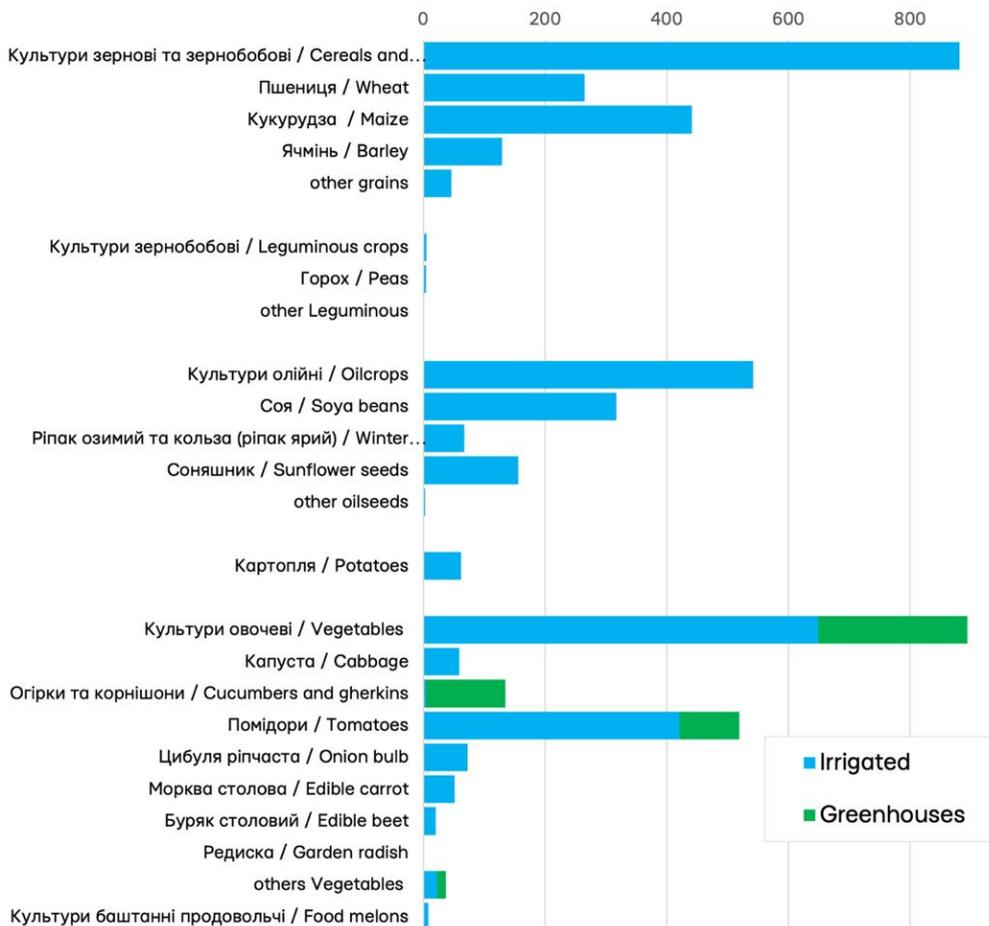
Zaporizhzhya, Dnipropetrovsk and Kherson Irrigation dependent Production (kMT)

Rates of the irrigation-dependent production are illustrated below:⁶⁰⁷

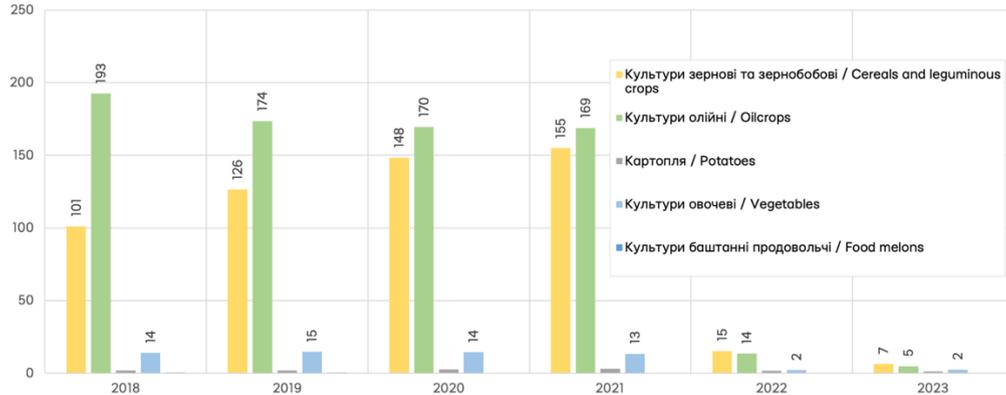
Zaporizhzhya, Dnipropetrovsk and Kherson Irrigation dependent Harvested Area (kHa)

Additionally, within each region, an analysis was conducted on the dynamics of both crop areas and production:⁶⁰⁸

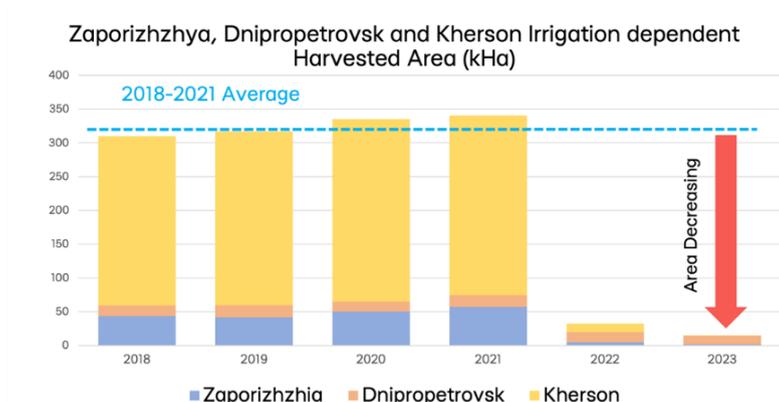
We evaluated the decrease in irrigation between 2018–2021 and 2023.⁶⁰⁹

In 2022, the irrigation area decreased due to the military actions, and partially because the Ukraine Statistics Department did not have access to the whole area and therefore could not measure it. In 2023, the data was partially available for Dnipropetrovsk irrigation area.

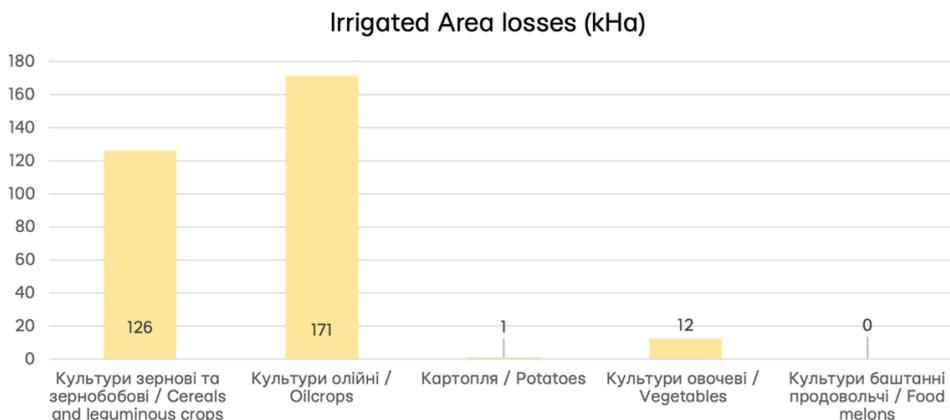
The next step was to determine the decrease in irrigation area:⁶¹⁰

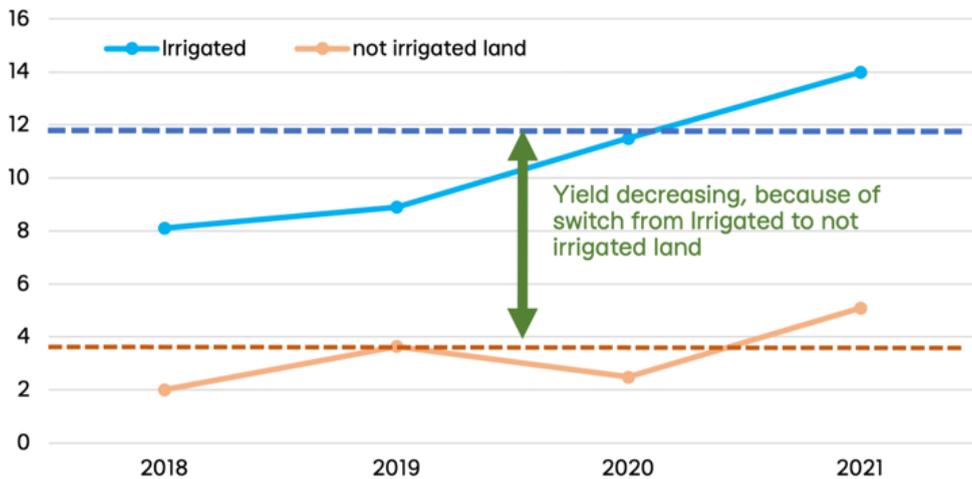
Zaporizhzhya Maize Yield (MT/Ha)

Below, see the yield decrease calculated as a difference from 2018–2021 average yield on the not-irrigated land and irrigated land:

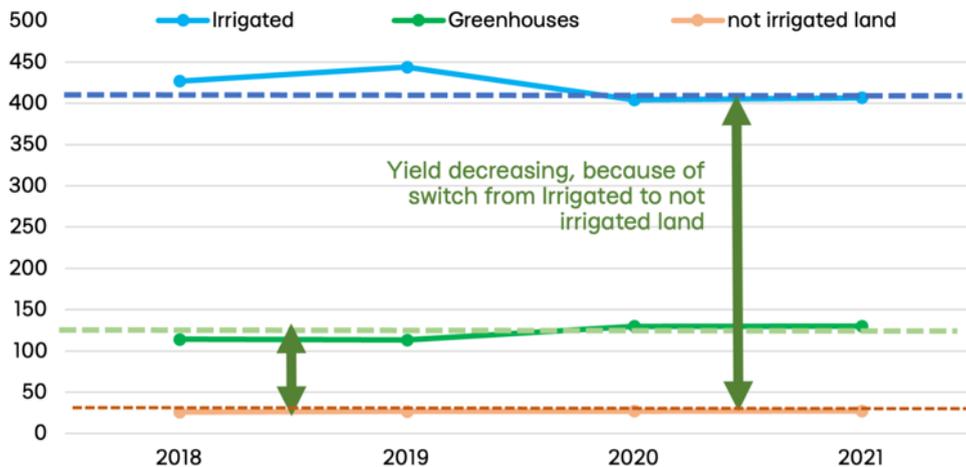
Kherson Tomatoes Yield (MT/Ha)

Consequently, we could convert [irrigation area decreasing] and [yield decreasing] into [production decreasing]. The logic of calculating losses is as follows: we make an assumption that in the territories where irrigation has disappeared, crops will be grown without it, which will result in a lower yield.

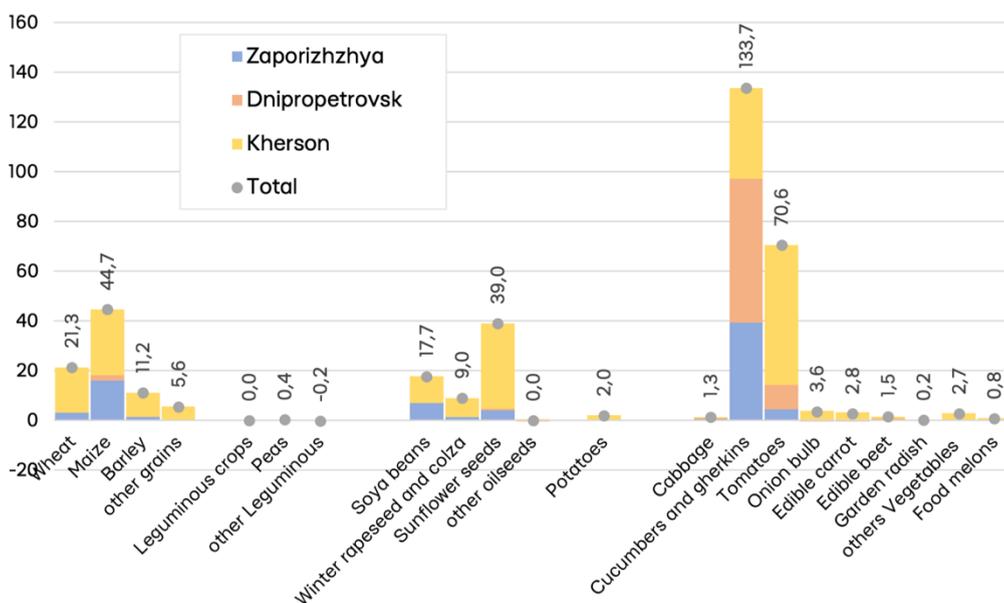
Next, we use the official prices of agricultural enterprises to convert the value of the tons lost into US dollar equivalents.⁶¹¹ As shown, the Dam’s destruction will lead to long-term depression of agricultural capacity in the impacted regions. This has the immediate consequence of destroying wealth and will likely impede prospects for long-term recovery since much of this area had been reliant on agriculture for economic output.

Losses due Irrigation shutdown \$M (TTL 367.9 per year)

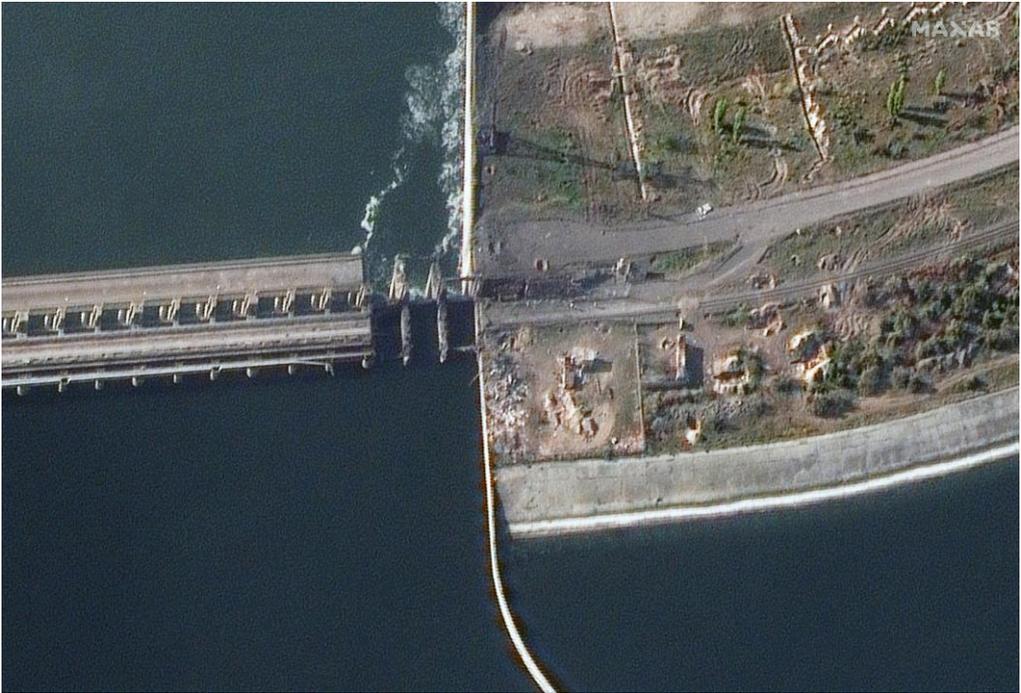
Satellite image of the damaged 3 spans by the Russian military
Source: Maxar, November 11, 2022⁷⁷³

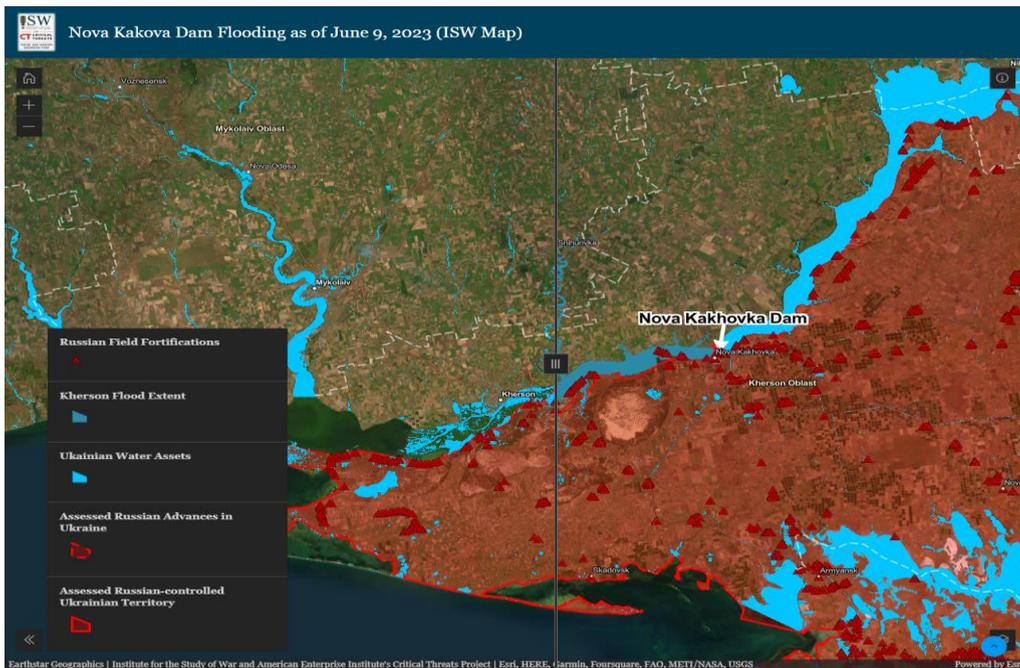
Map 2. Nova Kakhovka Dam Flooding as of July 9, 2023⁷⁹²
